PERI Rental Criteria

PERI UP Facade Scaffold Easy

Content	Page	Changes	Date Initial	Page
Steel Deck EDS	2	New Version	03/2017 fw	
Combi Deck EDW	6			
Frame parts	9			
Access Deck Ladder Access	12			
Diagonal	17			
Guardrail	19			
Accessories	23			
Glossary	27

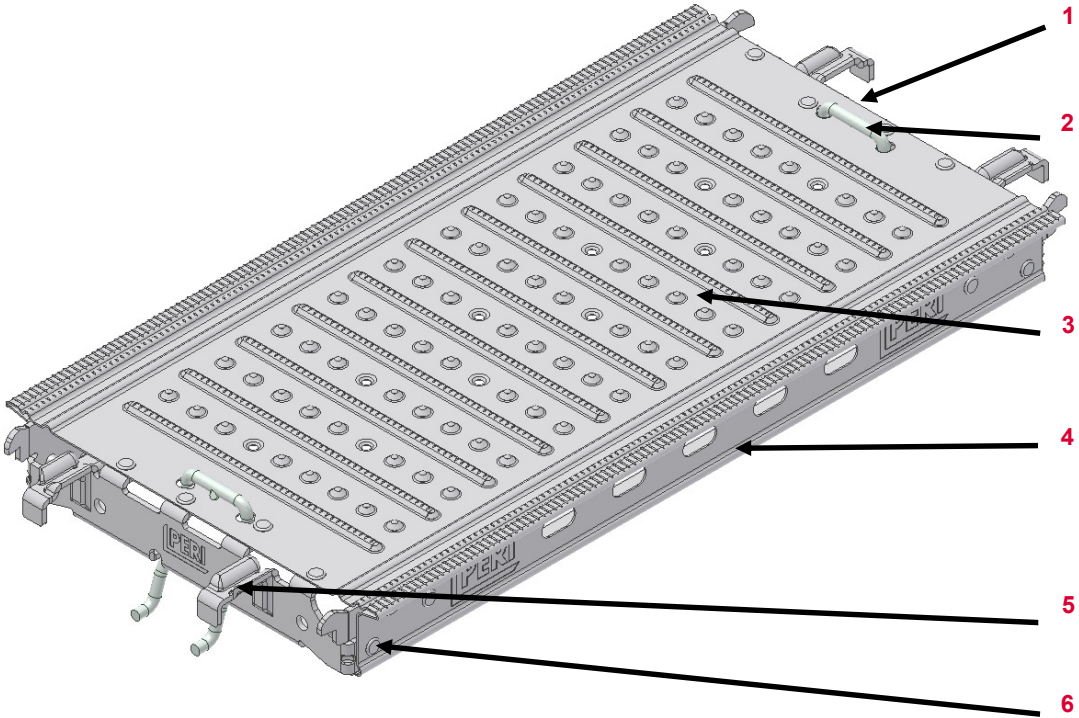
Steel Deck EDS	Nr.	Description	Article number
----------------	-----	-------------	----------------

1	Hinge EDS	129808
2	Safety hook	108716
3	Deck	
4	Side profile	
5	Connection Bracket	
6	Niet 6,0x 10	723058

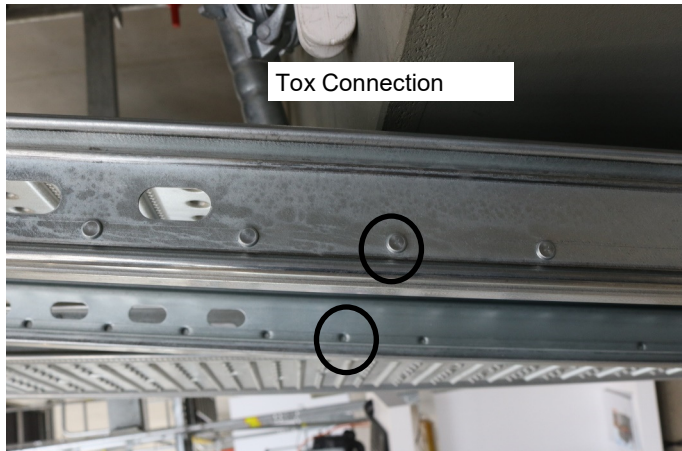
33.25.01 Edge profile bent

- Insertion of decking possible and no damage to Tox- Connection

- Or insertion not possible

- Damage to Tox- Connection

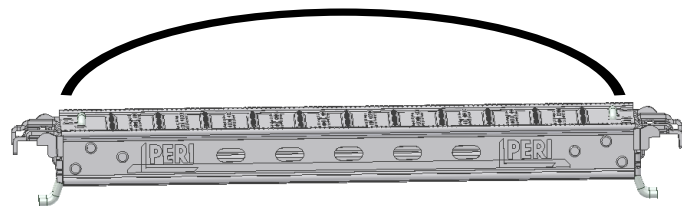
33.25.02 Deck bent

- < permitted bent (L/250)

- Or > permitted bent (L/250)

Article	Perm. bent
EDS 67 100	5 mm
EDS 150	6 mm
EDS 200	8 mm
EDS 250	10 mm
EDS 300	12 mm

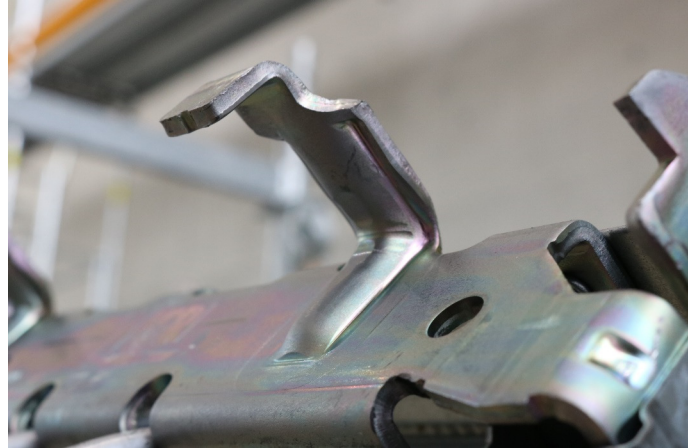
33.25.03 Claw bent			
	<ul style="list-style-type: none"> ■ ≤ 5 mm

<ul style="list-style-type: none"> ■ Or with cracks in claw

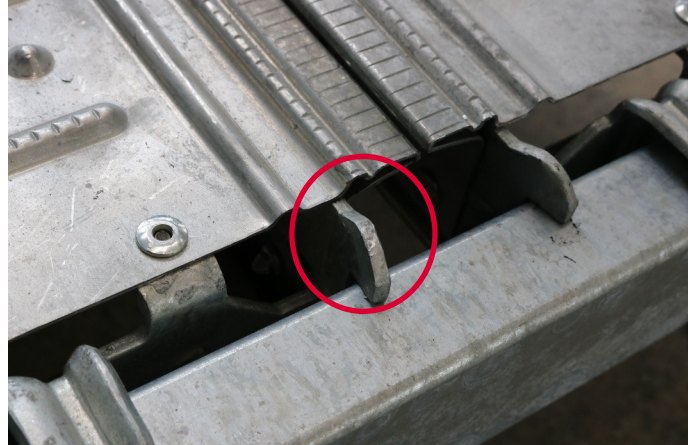
33.25.04 Hook at Hinge bent			
	<ul style="list-style-type: none"> ■ Without cracks in material

<ul style="list-style-type: none"> ■ Or with cracks in material

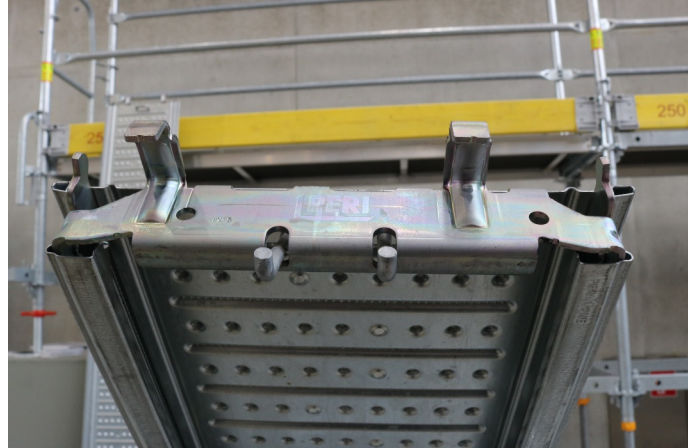
<p>33.25.05 Complete hinge bent</p>

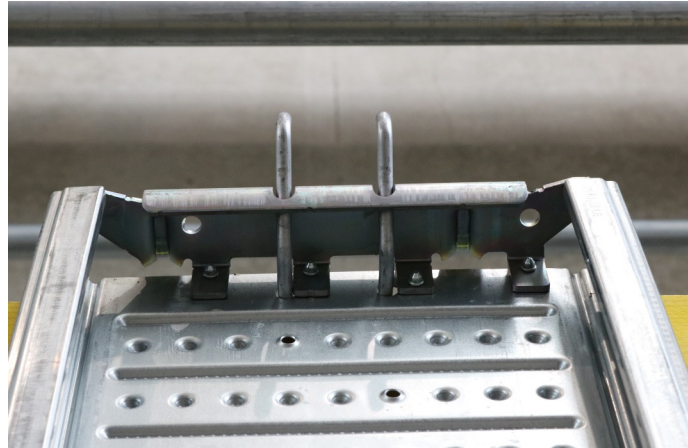
<p>33.25.06 Safety bracket bent unusable</p>

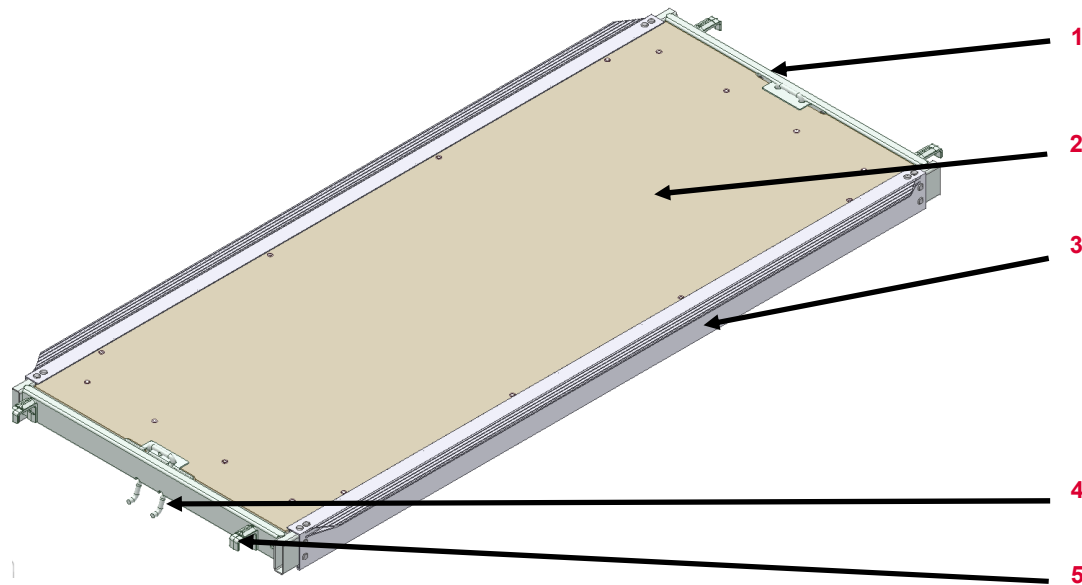
Combi Deck EDW

1	Hinge EDW	130308
2	Deck	
3	Side profile	
4	Safety bracket	
5	Connection bracket

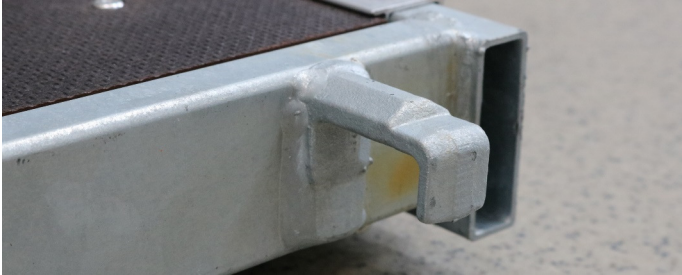
33.25.09 Claw bent <ul style="list-style-type: none"> ■ ≤ 5 mm and no cracks in claw

<ul style="list-style-type: none"> ■ Or > 5 mm ■ Or cracks in claw

130308

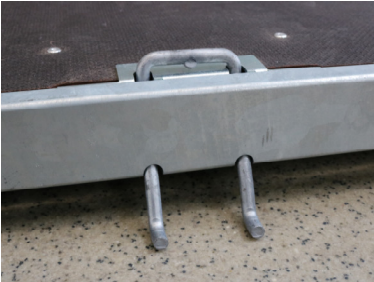
33.25.10 Safety bracket <ul style="list-style-type: none"> ■ Bent

<ul style="list-style-type: none"> ■ Or missing

130308

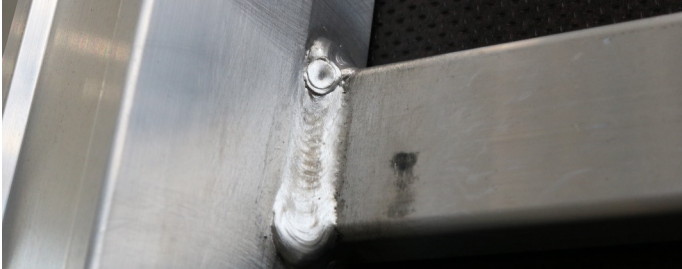
33.25.11 Welding broken at strut <ul style="list-style-type: none"> ■ With deformation of strut

<ul style="list-style-type: none"> ■ Or without deformation

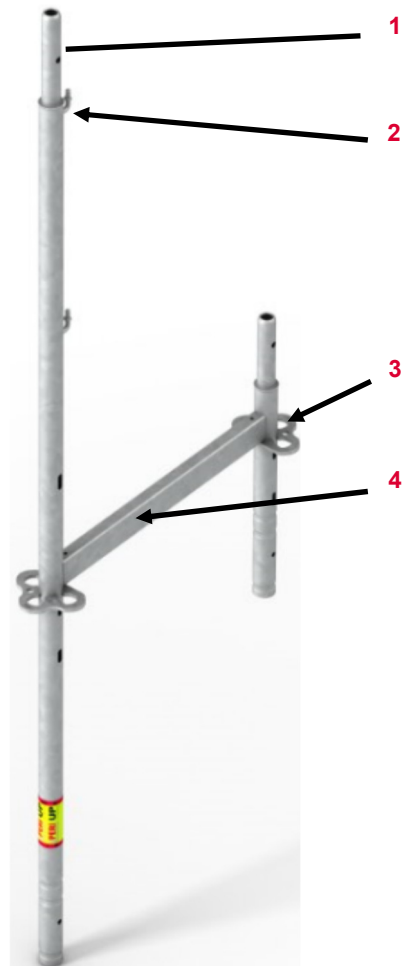
Head Frame EVH Easy Frame EVF Easy Frame EVB Tube EVR	Nr.	Description	Article number
---	-----	-------------	----------------

1	Spigot
2	Guardrail hook
3	3/4 Rosett
4	Horizontal tube

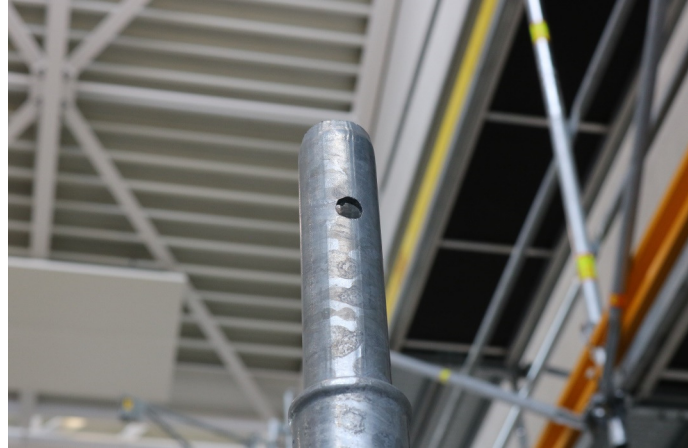
<p>33.25.12 Spigot Junction bent</p> <ul style="list-style-type: none"> ■ All visible deformations

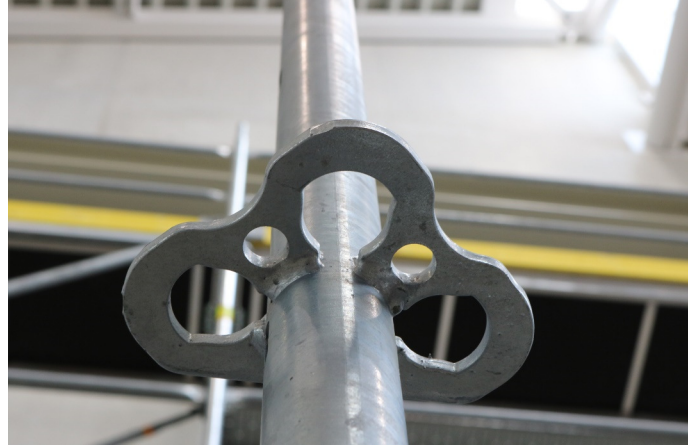
<p>33.25.13 Rosett bent</p> <ul style="list-style-type: none"> ■ If possible ■ Or welding cracked ■ Or bent > 20 mm

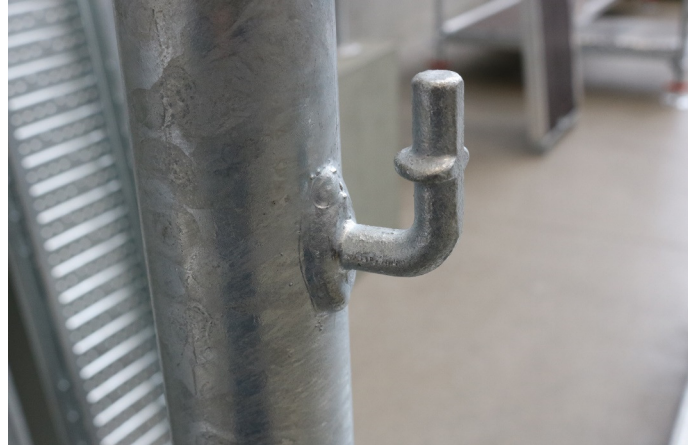
33.25.14 Guard rail bent			
	<ul style="list-style-type: none"> ■ If possible

<ul style="list-style-type: none"> ■ Cracks in material welding

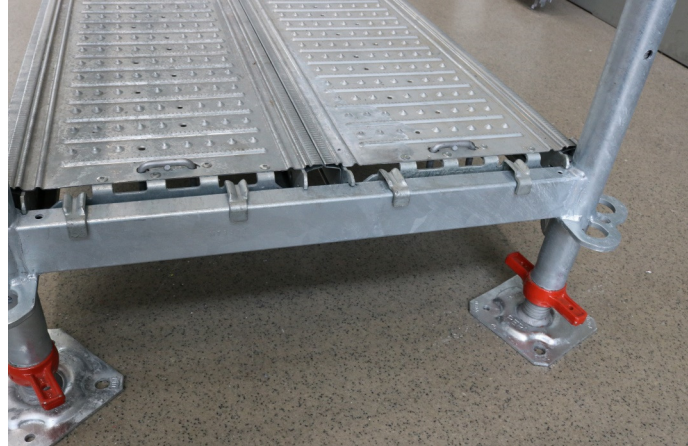
33.25.15 Dent horizontal tube			
	<ul style="list-style-type: none"> ■ $\varnothing \leq 3 \text{ cm}$

<ul style="list-style-type: none"> ■ Or crack

<ul style="list-style-type: none"> ■ Or edges of horizontal tube are affected

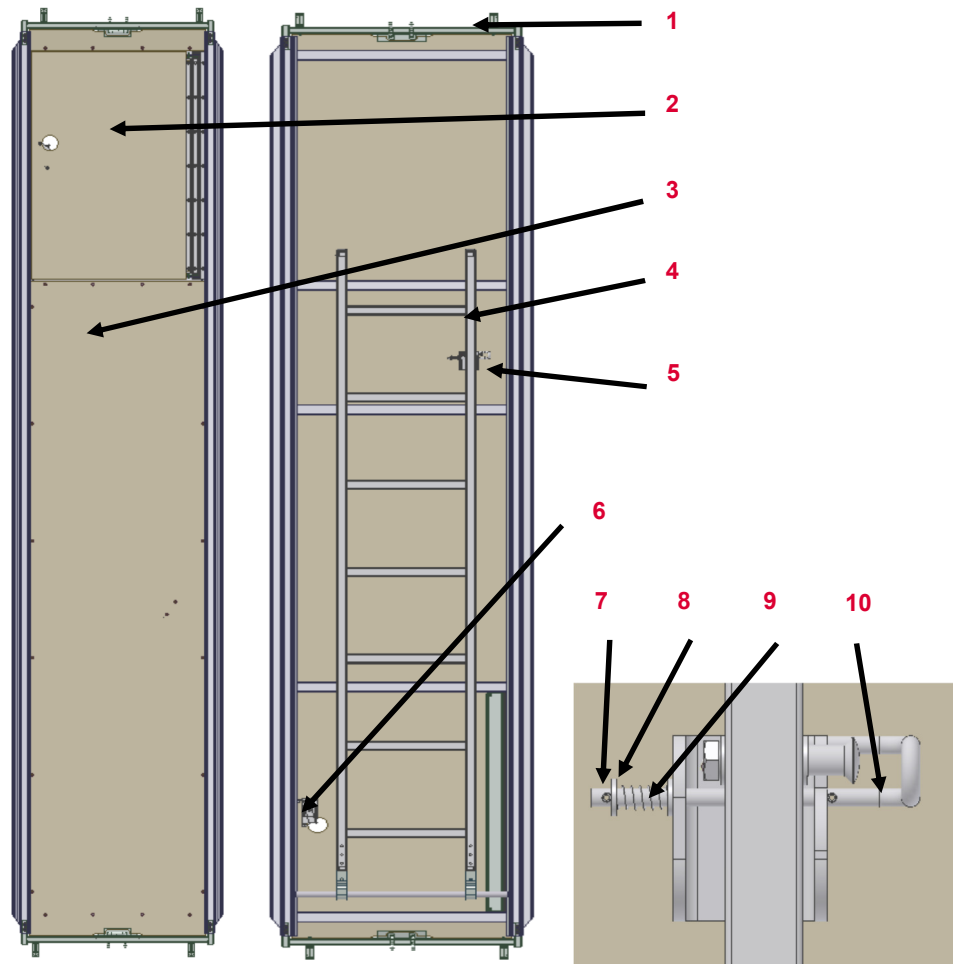
Ladder Access EAW Access Deck EAW		Nr.	Description	Article number
-------------------------------------	--	-----	-------------	----------------

1	Hinge	130308
2	Access Hatch	130412
3	Deck	
4	Ladder EAL	130419
5	Ladder Connection Bracket	130423
6	Latch UAL	115566
7	Dowel Pin	130356
8	Disc	721633
9	Spring	130386
10	Safety hook	130422

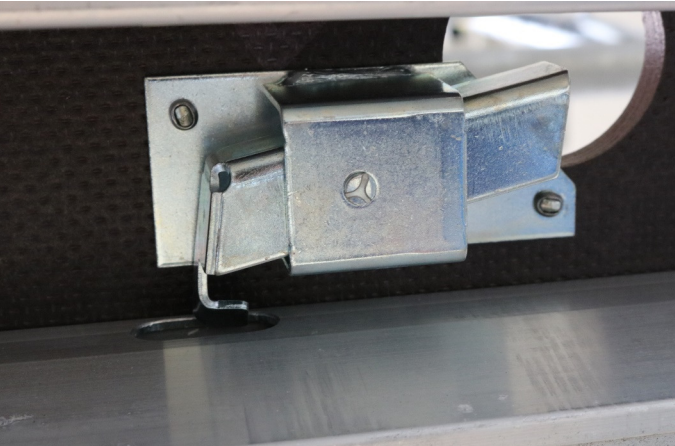
33.25.17 Latch not functional

- Worn
- Or damaged due to force

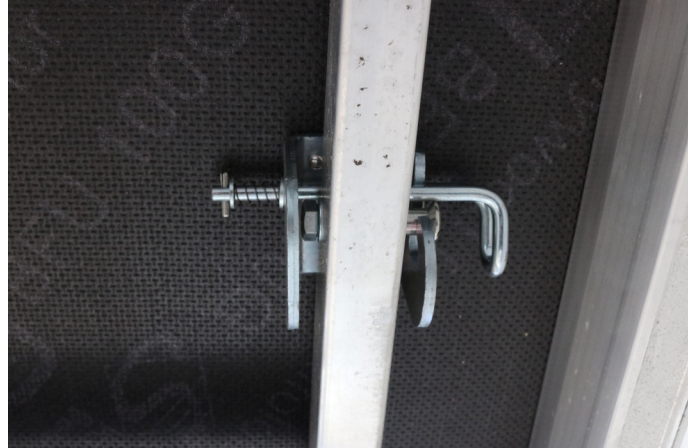
33.25.18 Ladder hinge			
	<ul style="list-style-type: none"> ■ Not functional because of weariness

<ul style="list-style-type: none"> ■ Or not functional due to force

<ul style="list-style-type: none"> ■ Or parts missing

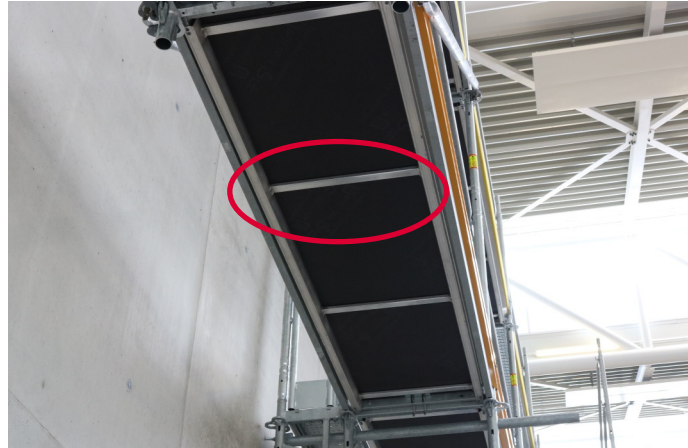
33.25.19 Strut bent			
	<ul style="list-style-type: none"> ■ If possible

<ul style="list-style-type: none"> ■ Or if welding cracked

<ul style="list-style-type: none"> ■ Or kink

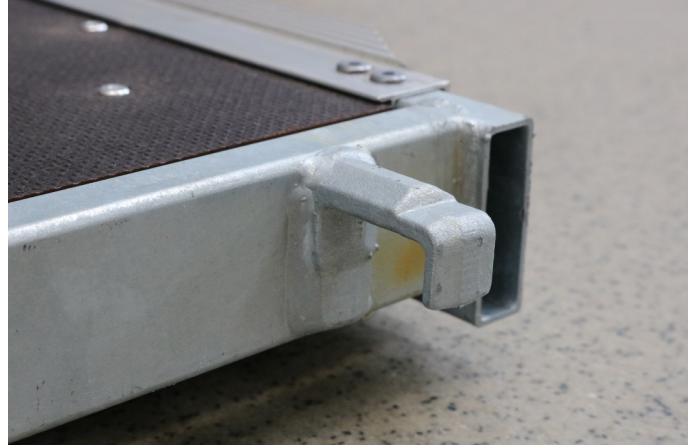
33.25.20 Claw bent			
	<ul style="list-style-type: none"> ■ ≤ 5 mm

<ul style="list-style-type: none"> ■ Or > 5 mm

<ul style="list-style-type: none"> ■ Or cracks in claw

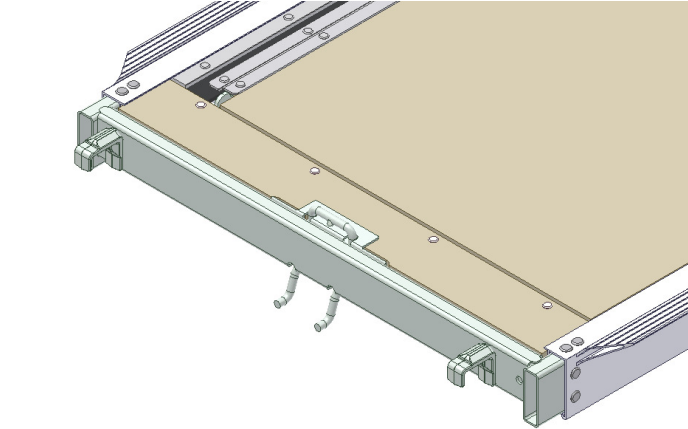
33.25.21 Hinge bent not usable

130308 (Hinge) 722318 (Rivet 6,0 x 10)

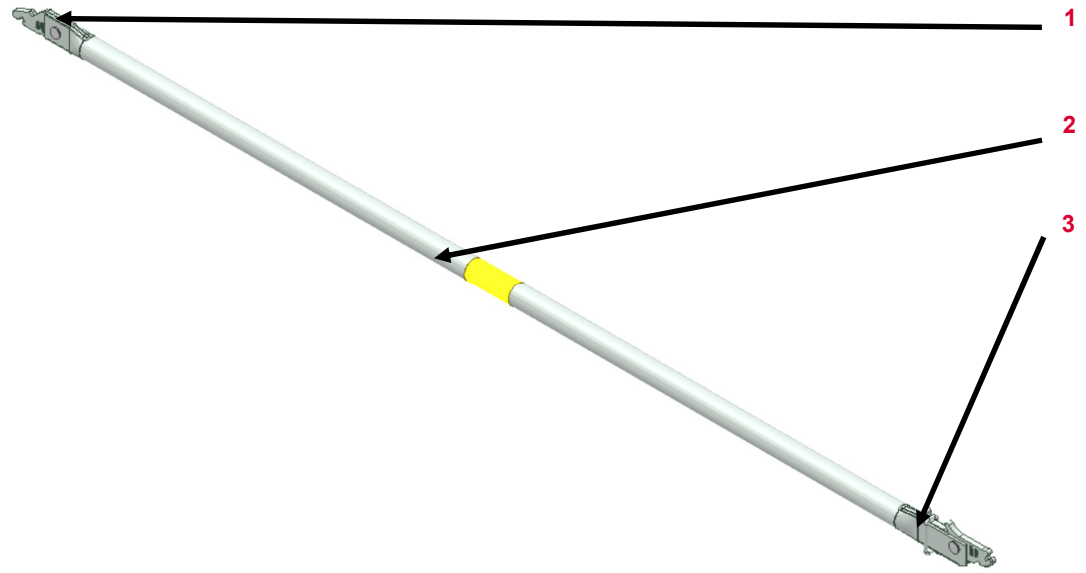
Face Brace EBF	Nr.	Description	Article number
----------------	-----	-------------	----------------

1	Diagonal head bottom
2	Tube
3	Diagonal head top

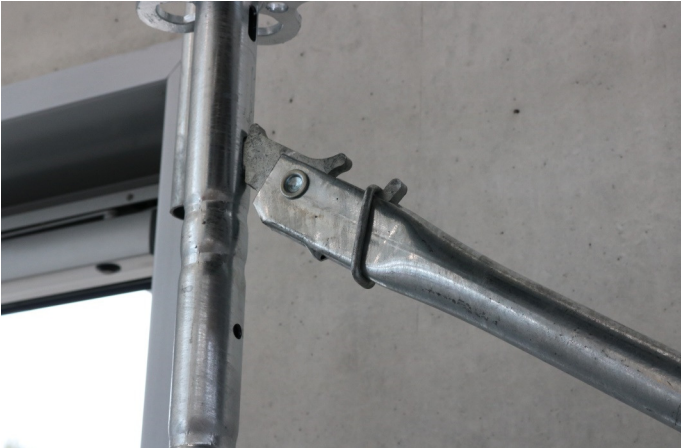
33.25.24 Diagonal head not usable

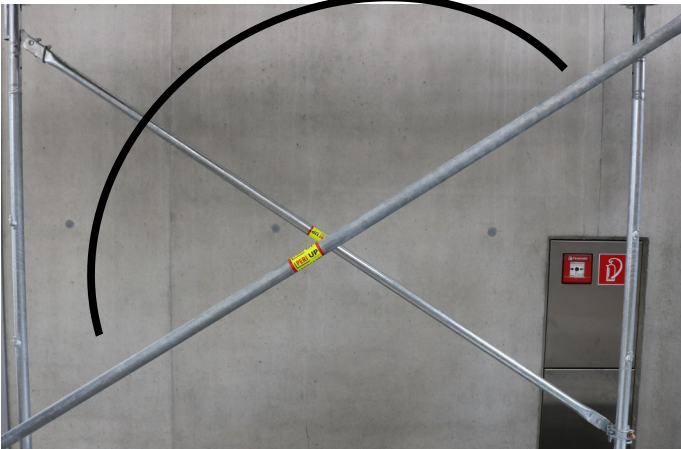
33.25.25 Diagonals bent

■ ≤ permitted bent (L/500)

■ Or > permitted bent (L/500)

Article	Perm. bent
Face Brace EBF 150/200	4 mm
Face Brace EBF 200/200	5 mm
Face Brace EBF 250/200	6 mm
Face Brace EBF 300/200	7 mm

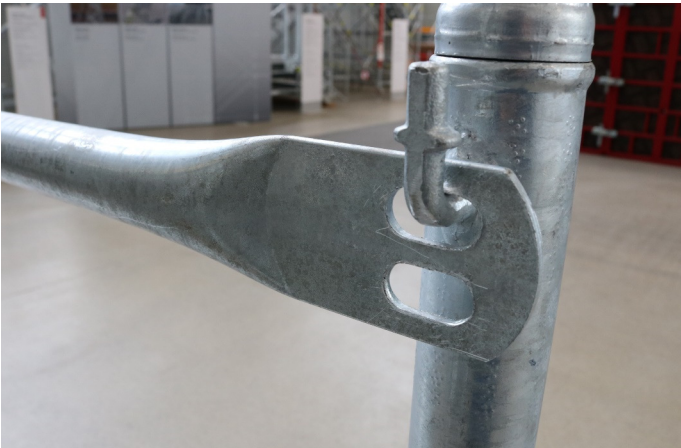
33.25.26 Connector bent

■ If possible

■ If not possible

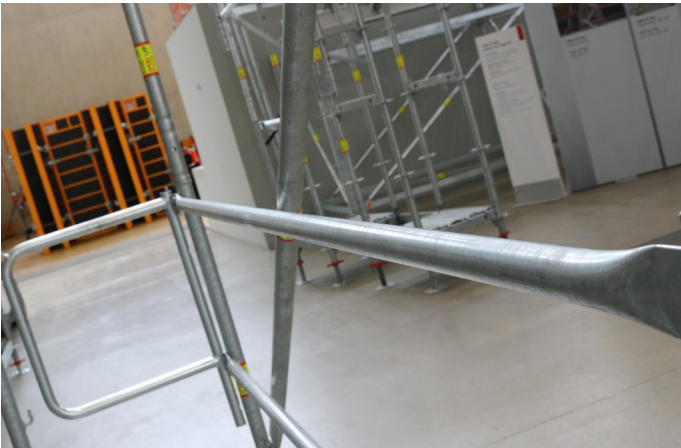
33.25.27 Guardrails bent

■ > permitted bent (L/250)

Article	Perm. bent
Guardrails EPG 67	3 mm
Guardrails EPG 100	4 mm
Guardrails EPG 150	6 mm
Guardrails EPG 200	8 mm
Guardrails EPG 250	10 mm
Guardrails EPG 300	12 mm

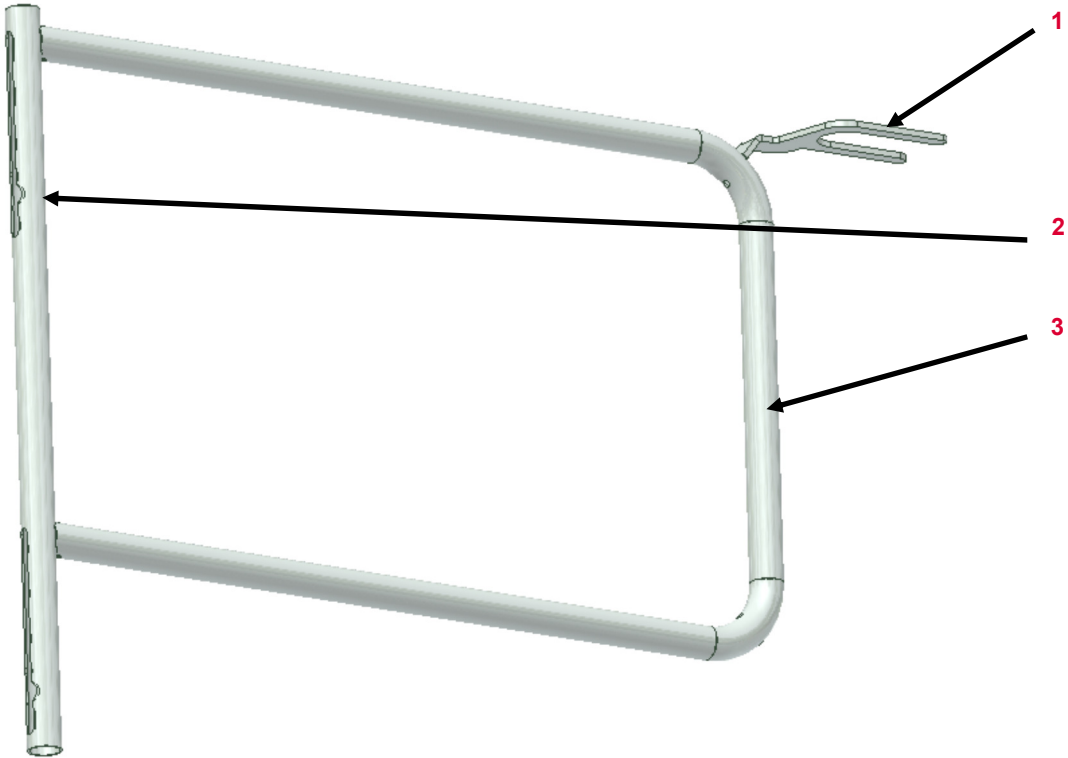
Stop- and Handrails EPF	Nr.	Description	Article number
-------------------------	-----	-------------	----------------

1	Fork
2	Tube
3	Frame

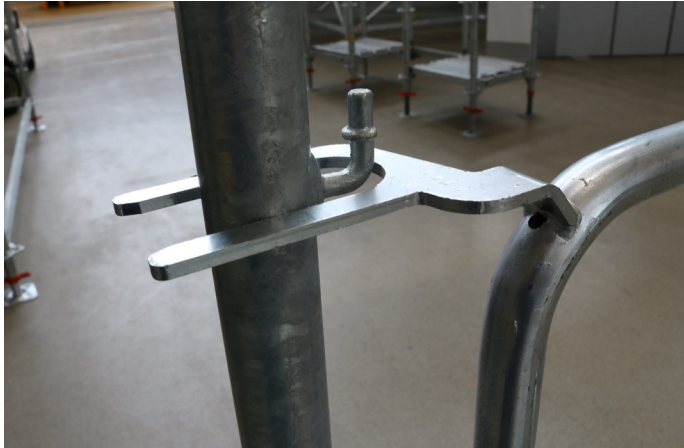
33.25.28 Fork bent

- If possible
- Or if not possible

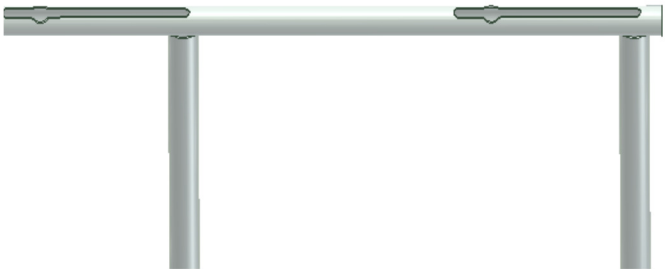
33.25.29 Tube squashed

- Insertion possible
- Or no longer possible

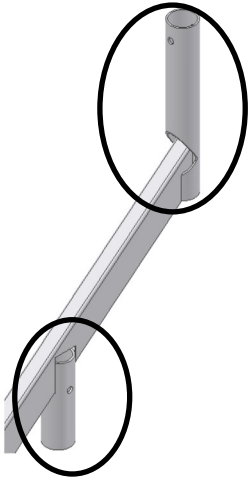
<p>33.25.30 Connection tubes bent squashed</p> <ul style="list-style-type: none"> ■ Every visible deformation

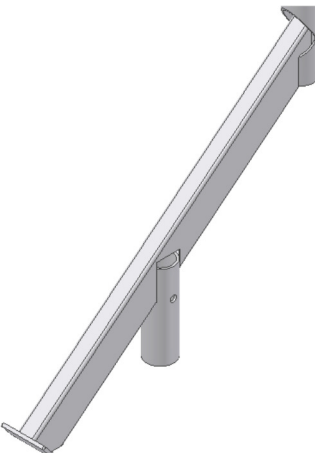
<p>33.25.31 Dent in tube</p> <ul style="list-style-type: none"> ■ $\varnothing > 3$ cm ■ Or edges affected

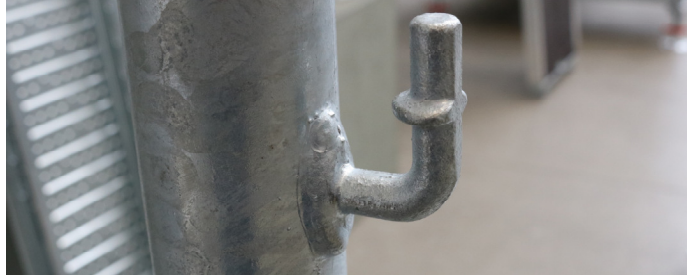
<p>33.25.32 Guardrail hook bent</p> <ul style="list-style-type: none"> ■ If possible ■ Or if not possible 	<ul style="list-style-type: none"> ■ If possible:

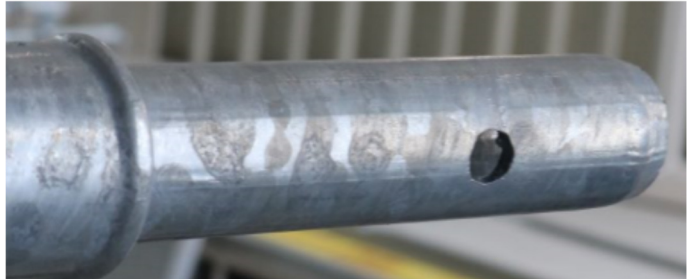
<p>33.25.33 Spigot connection bent</p> <ul style="list-style-type: none"> ■ All visible deformations 	<ul style="list-style-type: none"> ■ All visible deformations:

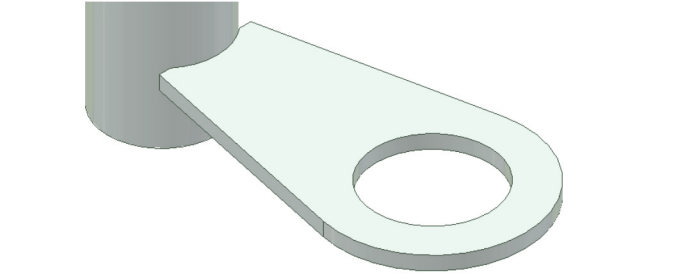
<p>33.25.34 Junction sheet bent</p> <ul style="list-style-type: none"> ■ If possible ■ Or if not possible 	<ul style="list-style-type: none"> ■ If possible:

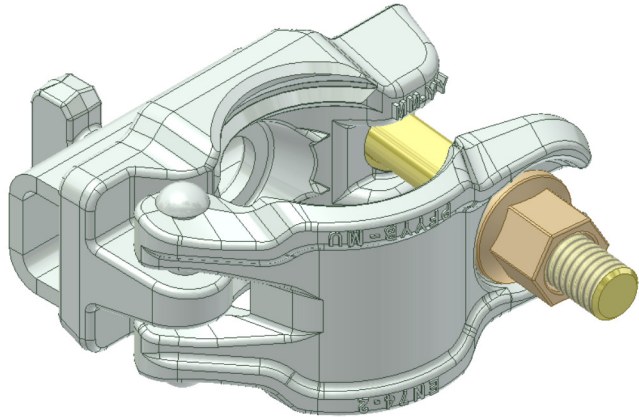
33.25.35 Hinge not functional			
	<ul style="list-style-type: none"> ■ Worn

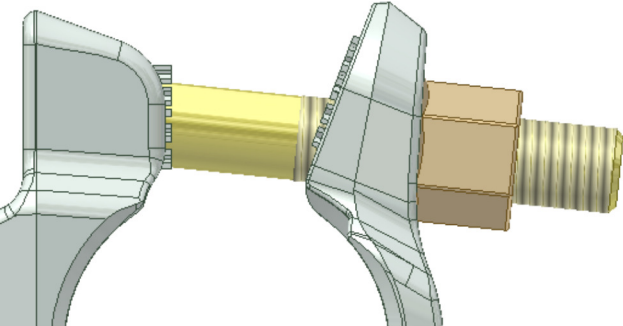
33.25.36 Hammer head bolt Nut			
	<ul style="list-style-type: none"> ■ Missing

<ul style="list-style-type: none"> ■ Or damaged

<p>131316 (Hammer head bolt) 710340 (Nut)</p>

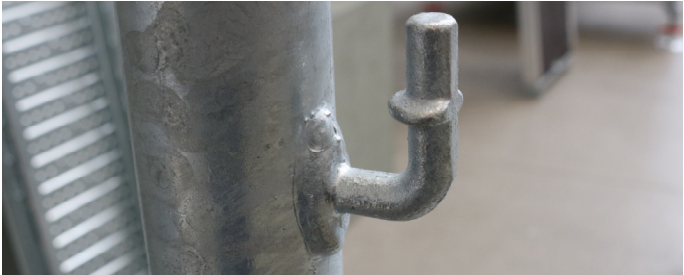
33.25.37 Guardrail hook bent	<ul style="list-style-type: none"> ■ If possible

<ul style="list-style-type: none"> ■ Or if not possible

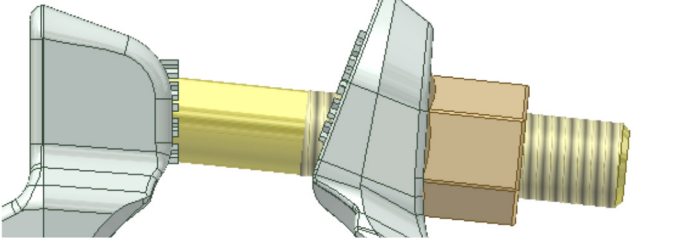
33.25.38 Hammer head bolt Nut	<ul style="list-style-type: none"> ■ Missing

<ul style="list-style-type: none"> ■ Or are damaged

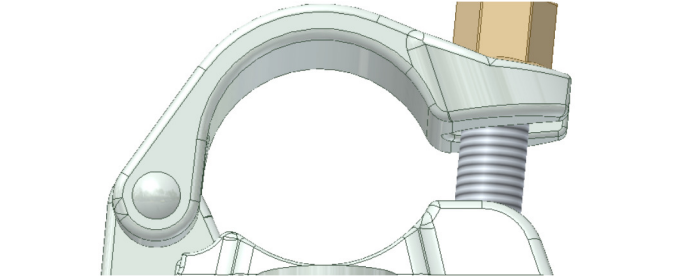
33.25.39 Hinge not functional	<ul style="list-style-type: none"> ■ Worn

<ul style="list-style-type: none"> ■ Or damaged due to force
