PERI Rental Criteria

AB225

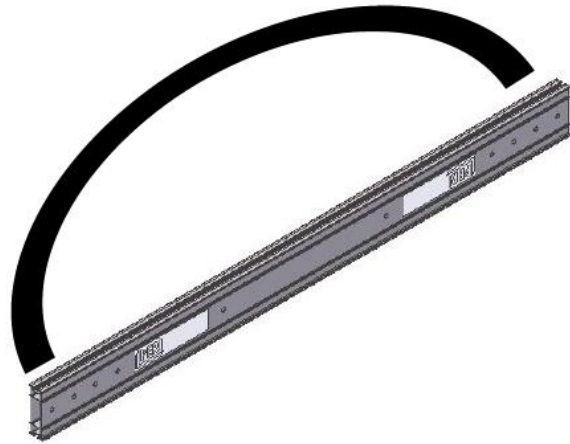
60.20.01.03 Beam bent

- ≤ permitted bent
- > permitted bent

| Component | Perm. bending |
| AB225 1800 | 3 mm |
| AB225 2400 | 4 mm |
| AB225 2700 | 5 mm |
| AB225 3000 | 6 mm |
| AB225 3600 | 7 mm |
| AB225 4800 | 9 mm |
| AB225 5400 | 10 mm |
| AB225 5900 | 11 mm |

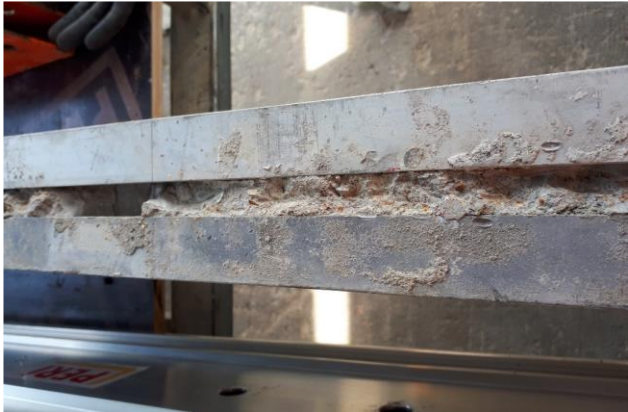
| AB225 | Description | Instruction | Billing Instruction | Type |
|---|---|--|--|--|
| | <p>60.20.01.04 Soiled guide profile</p> <ul style="list-style-type: none"> ▪ if possible ▪ if not possible | | | |

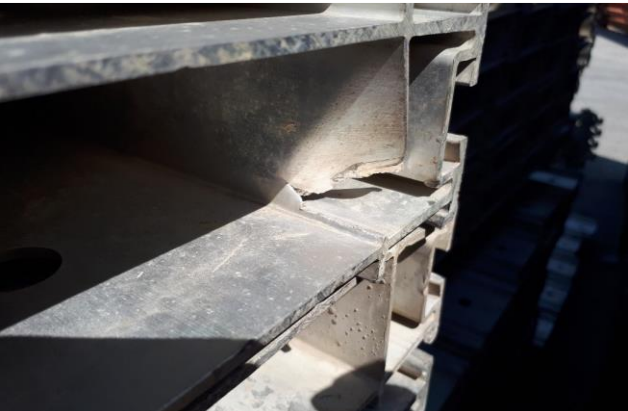
| AB225 | Description | Instruction | Billing Instruction | Type |
|---|---|--|--|--|
| | <p>60.20.01.05 Cracks in the inner profile</p> | | | |

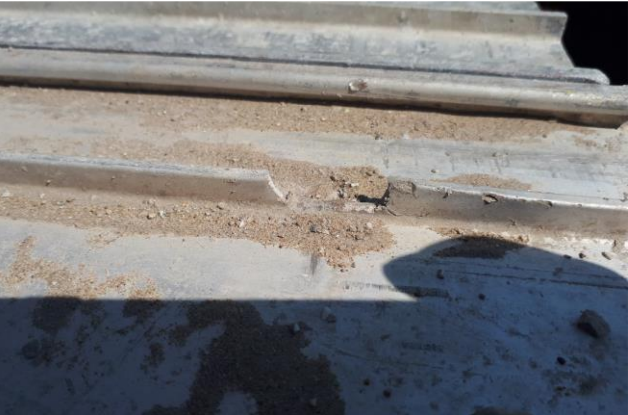
| AB225 | Description | Instruction | Billing Instruction | Type |
|--|---|---|---|---|
| | 60.20.01.06 Crack in outer profile | | | |
