# PERI Rental Criteria

## VRB Heavy-Duty Truss Girder

Changes	Date   Initial	Page
New version	04/2016   fw

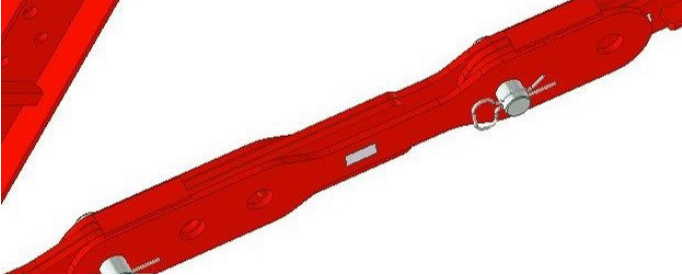
04.18.01 Tendon bent / defect

Tendon (126547)

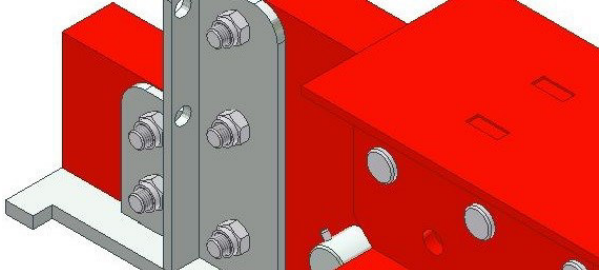
04.18.03 „Teleskopkastenschuh“ bent / ripped

„Teleskopkastenschuh“ (128084)

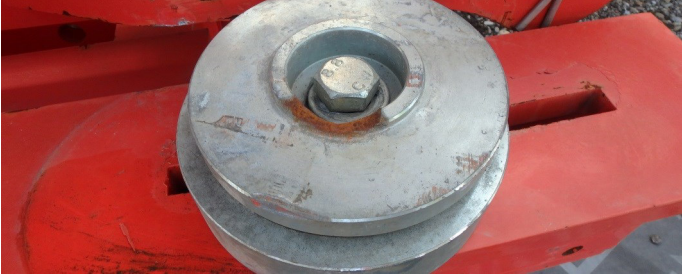
<b>04.18.04 Broken calotte</b>

Calotte (125446)

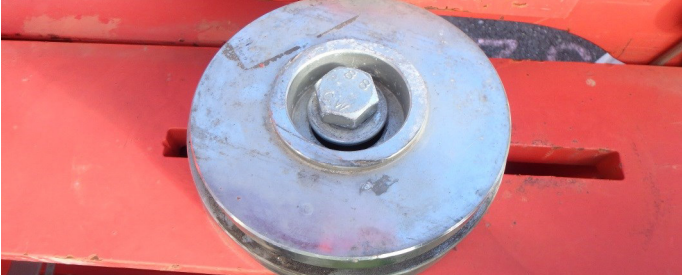
<b>04.18.05 Calotte no longer functional</b>			
	<ul style="list-style-type: none"> <li>■ If possible</li> <li>■ Or if not possible</li> </ul>	<ul style="list-style-type: none"> <li>

Calotte (125446)</li> </ul>	<ul style="list-style-type: none"> <li>

Lubricate afterwards</li> <li>

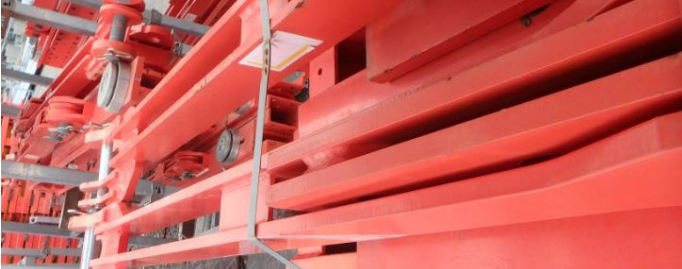
<b>04.18.06 Pull bar bent</b>

Pull bar (125179)

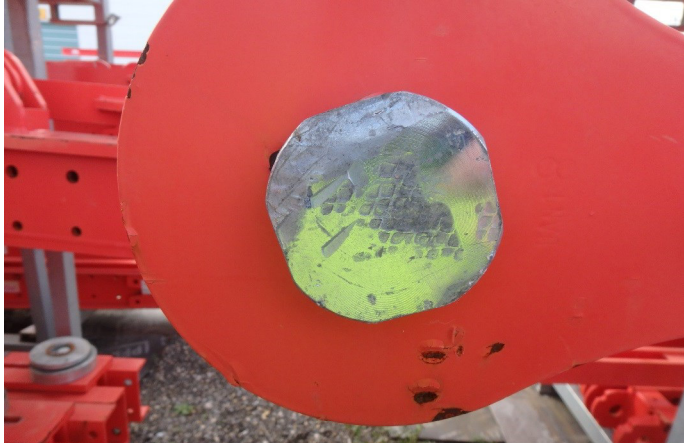
<p><b>04.18.08 Deformed bolts</b></p> <ul style="list-style-type: none"> <li>Without rips in the material</li> </ul>

<ul style="list-style-type: none"> <li>Or with rip in the material</li> </ul>

<p>Bolt(125356)</p>

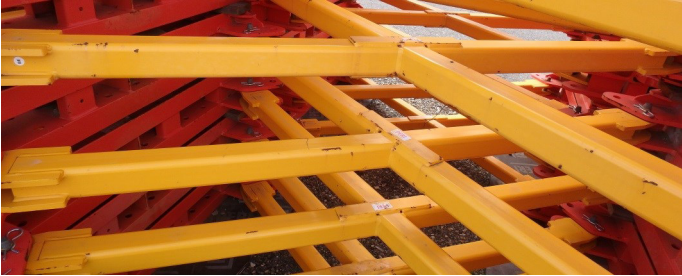
<b>04.18.09 Diagonal brace bent / broken</b>

Diagonal brace(125409)

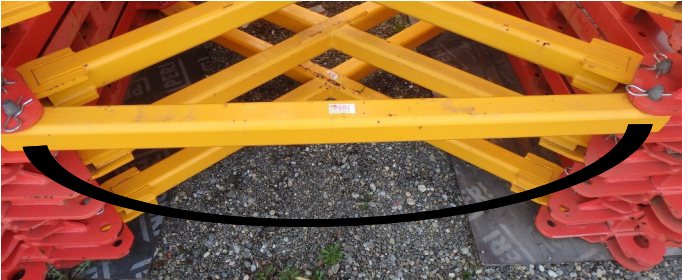
<b>04.18.10 „Druckpfosten“ bent / broken</b>  ■ > 3,0 mm (l/500)

„Druckpfosten“ (125413)

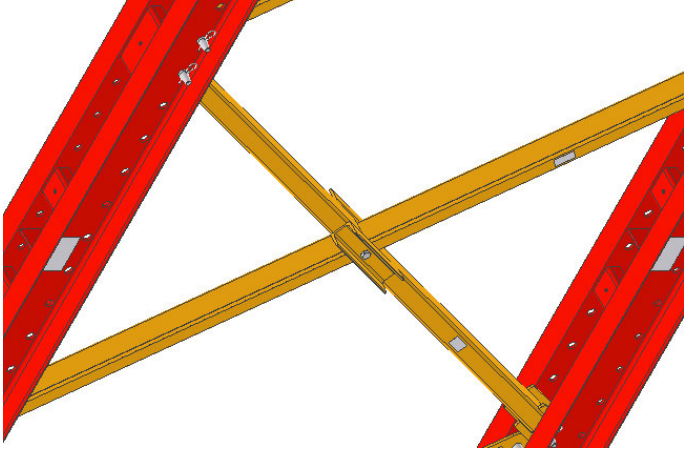
<p><b>04.18.12 Diagonals bent</b></p> <ul style="list-style-type: none"> <li>■ L &gt; 5 mm (l/500)</li> </ul>

<p>Diagonal continuous (125381) Diagonal discontinuous (125371)</p>

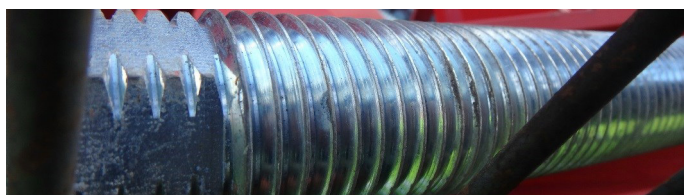
### 04.18.14 Threaded bar

- Soiled
- Or bent
