# PERI Rental Criteria

## ST 100 Stacking Tower

### Base Head Frame, Stacking Frame; End Frame

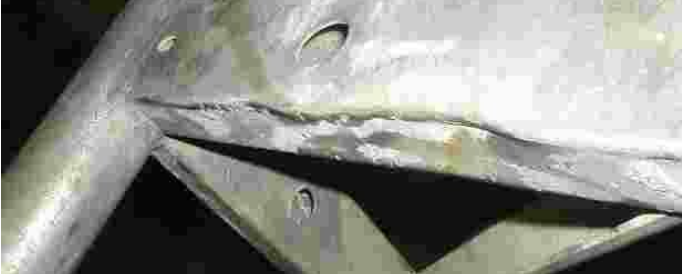
<b>Frame dent or bent</b>			
	<ul style="list-style-type: none"> <li>■ <math>D \leq 10 \text{ mm}</math></li> </ul>

<ul style="list-style-type: none"> <li>■ Or <math>d &gt; 10 \text{ mm}</math></li> <li>■ Or edge affected</li> </ul>

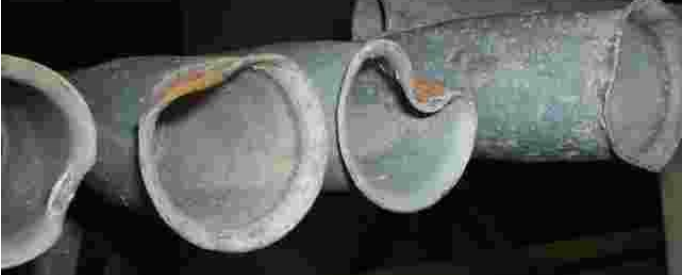
<b>Tube cup end bent</b>			
	<ul style="list-style-type: none"> <li>■ <math>\leq 10 \text{ mm}</math></li> <li>■ Or <math>&gt; 10 \text{ mm}</math></li> </ul>

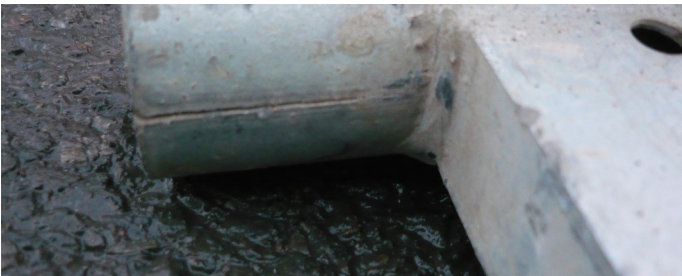
<b>Crack in tube cup end</b>			
	<ul style="list-style-type: none"> <li>■ Crack because of missuse (Bent in tube cup end)</li> <li>■ Or without damage of the tube cup end</li> </ul>

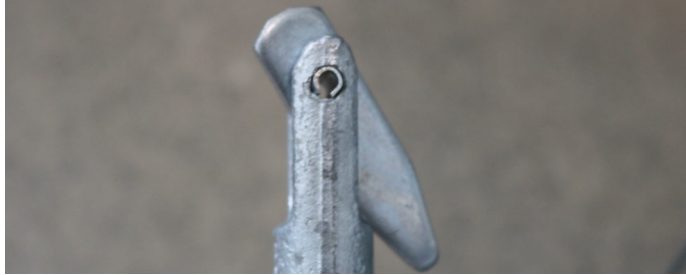
<p><b>Profile bent   missing</b></p>

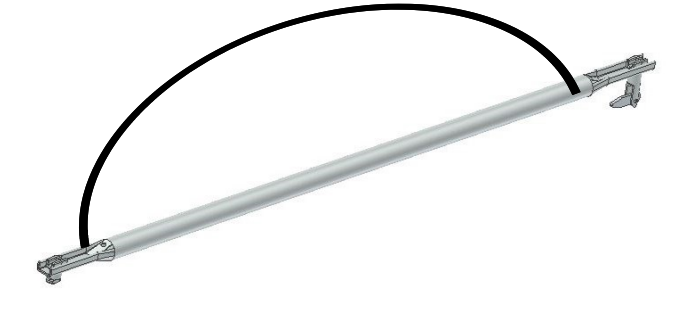
<p><b>Brace bent</b></p> <ul style="list-style-type: none"> <li>■ ≤ 3 mm</li> <li>■ Or &gt; 3 mm (L/500)</li> </ul>	<ul style="list-style-type: none"> <li>

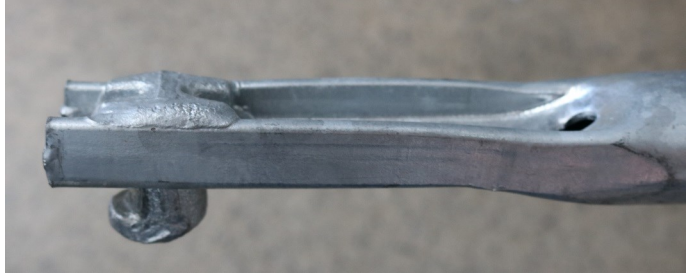
<p><b>Connection bent</b></p> <ul style="list-style-type: none"> <li>■ ≤ 5 mm</li> <li>■ Or &gt; 5 mm</li> </ul>	<ul style="list-style-type: none"> <li>

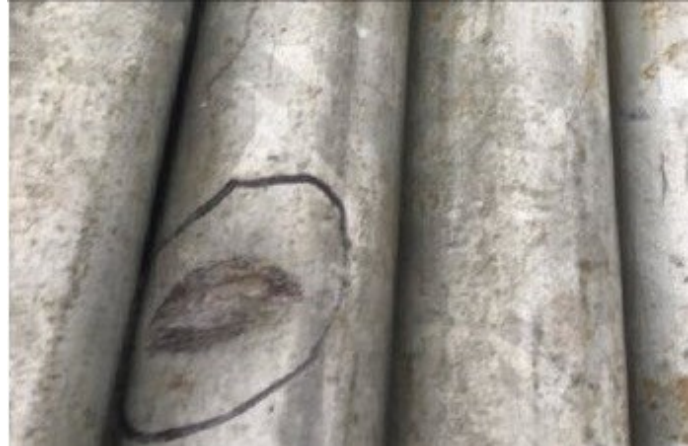
<p><b>Dent in tube</b></p> <ul style="list-style-type: none"> <li>■ ≤ 3 mm depth</li> <li>■ Or &gt; 3 mm depth</li> </ul>	<ul style="list-style-type: none"> <li>

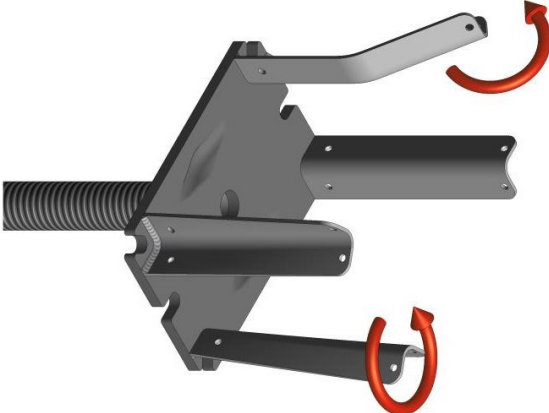
<p><b>Plaid</b></p> <ul style="list-style-type: none"> <li>■ Bent without crack in welding</li> <li>■ Or with crack in welding</li> <li>■ Or missing</li> </ul>	<ul style="list-style-type: none"> <li>

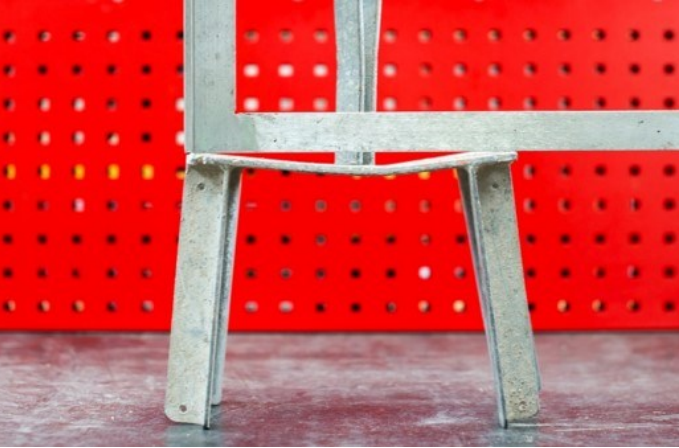
<p><b>Base plate bent</b></p> <ul style="list-style-type: none"> <li>■ &gt; 5 mm</li> </ul>	<ul style="list-style-type: none"> <li>

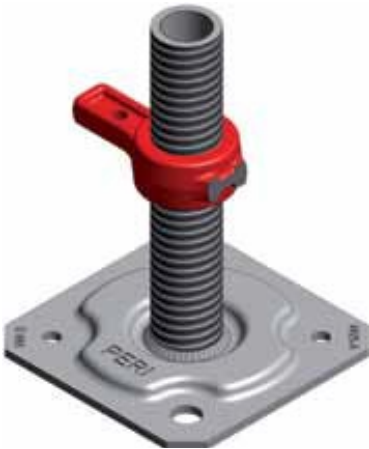
Wing nut broken

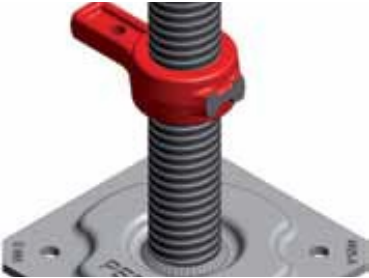
Wing nut broken

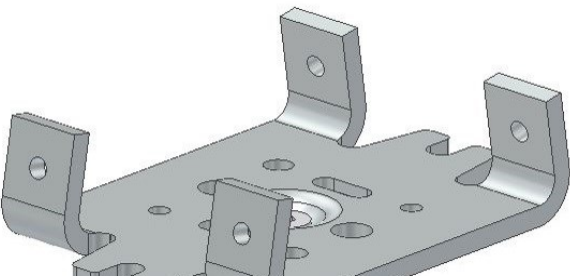
Claws bent

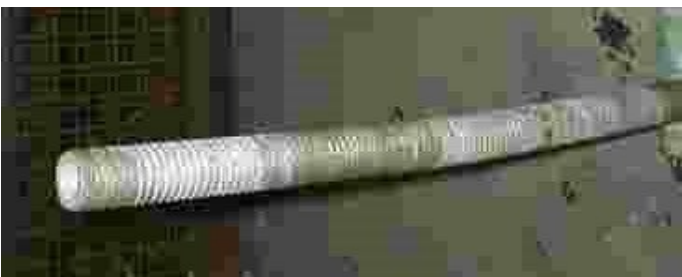
Spindle bent

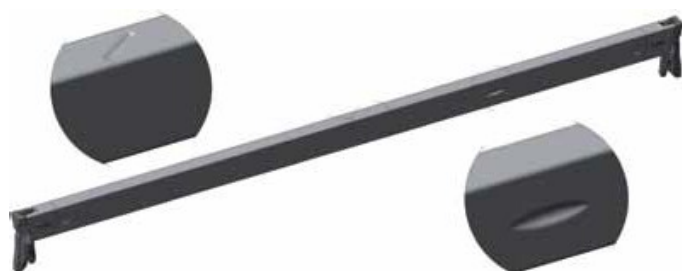
<p>Dent in profile</p>

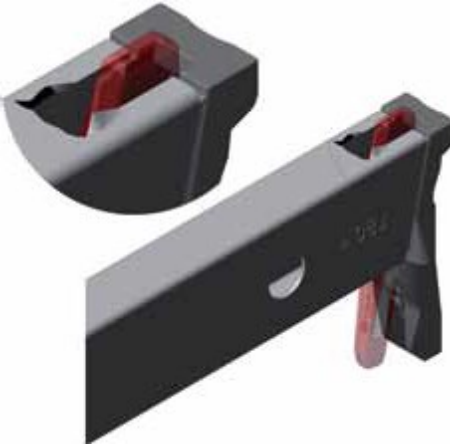
<p>Crack in wedge opening   Wedge is missing</p>

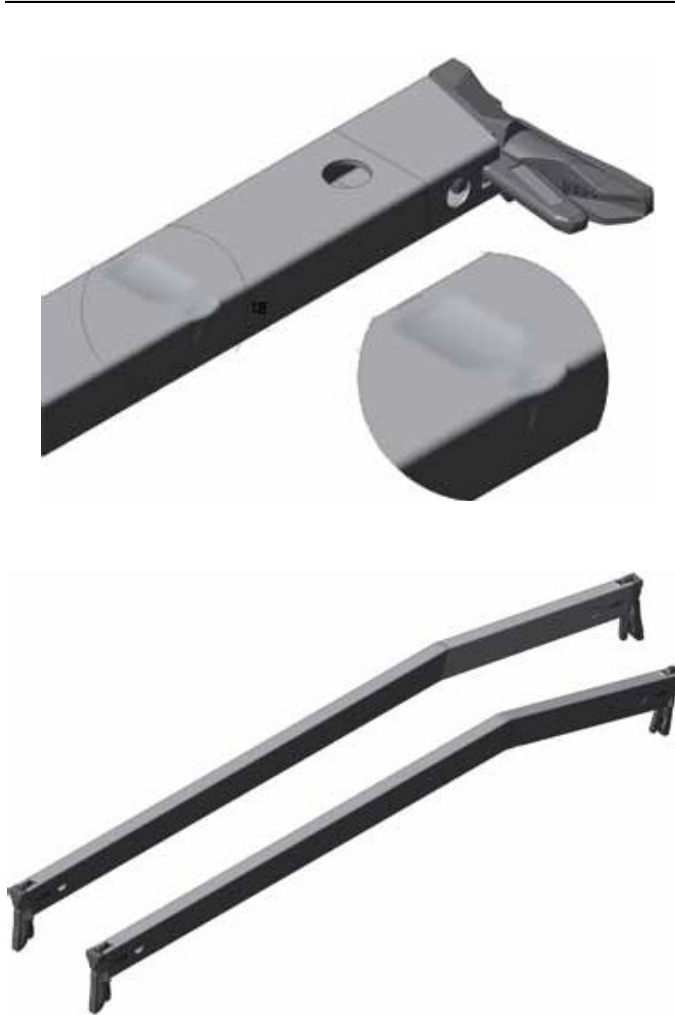
<p>Bent at the edge</p>

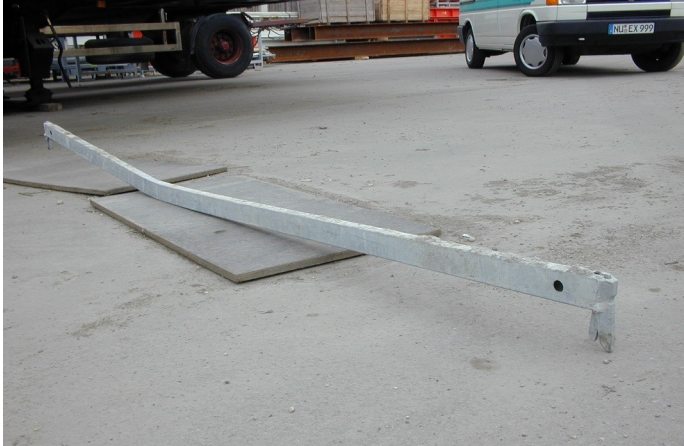
Profile bent in vertical direction

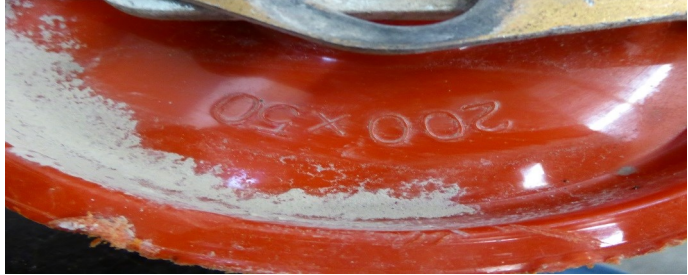
<p><b>Wheel</b></p> <ul style="list-style-type: none"> <li>■ Broken because of overloading the wheel</li> <li>■ Or worn</li> </ul>	<ul style="list-style-type: none"> <li>

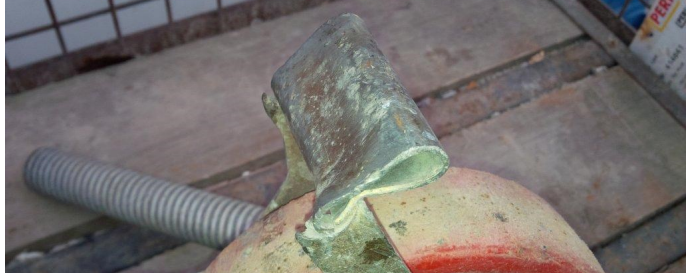
<p><b>Impact protection broken</b></p>	<ul style="list-style-type: none"> <li>

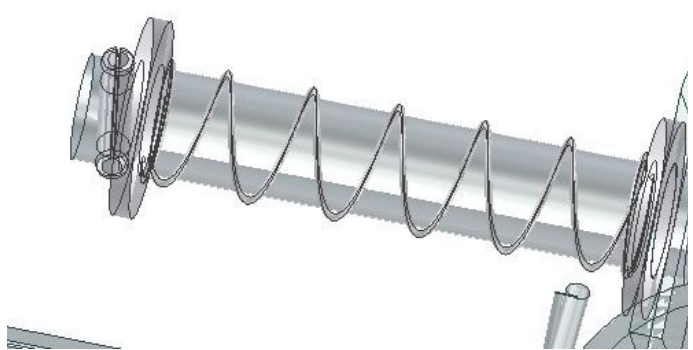
<p>Damaged spring</p>

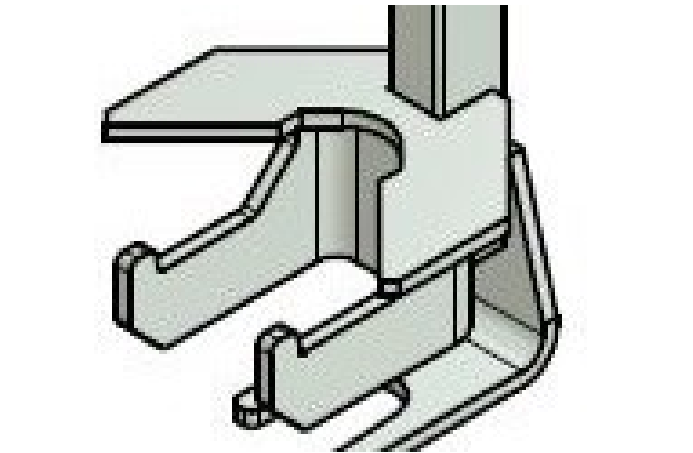
<p>Claws bent</p>

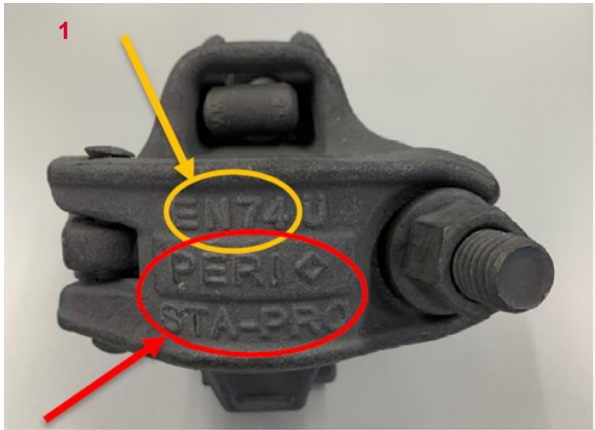
1	Reference to EN 74
2	Name or trademark of manufacturer. <b>It does not necessarily have to be PERI</b>
3	Quality grade of coupling
4	Year of manufacturer

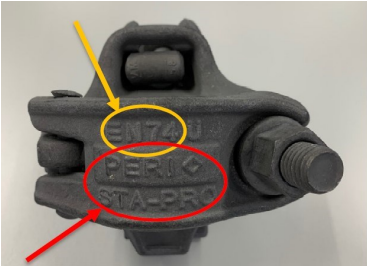
**Markings**

- Given
- Or not given

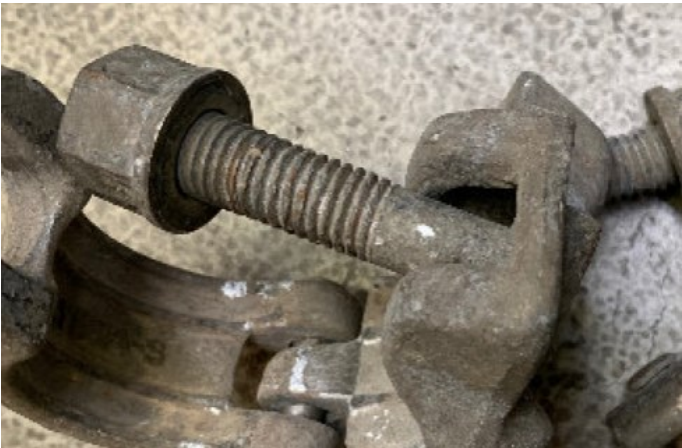
**Hammer Head Bolt | Nut**

- Missing
- Or damaged due to force
- Or not moveable du to weariness (rust)

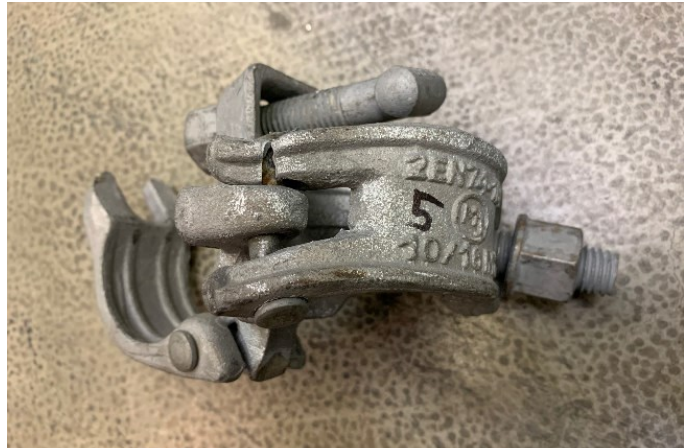
<p>Coupling half shell damaged</p>

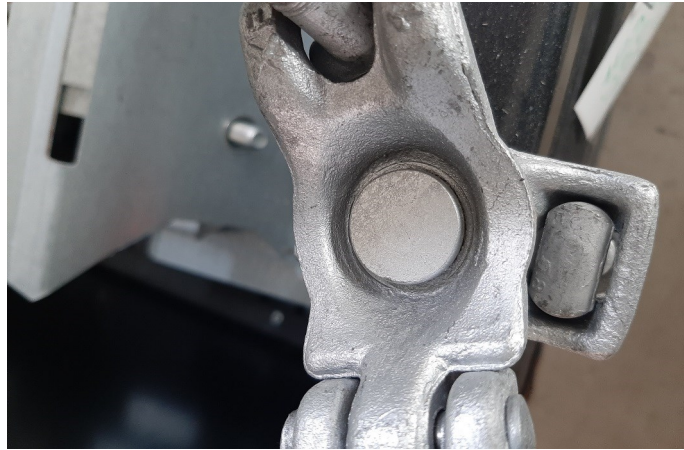
<p>Swivel element damaged</p>

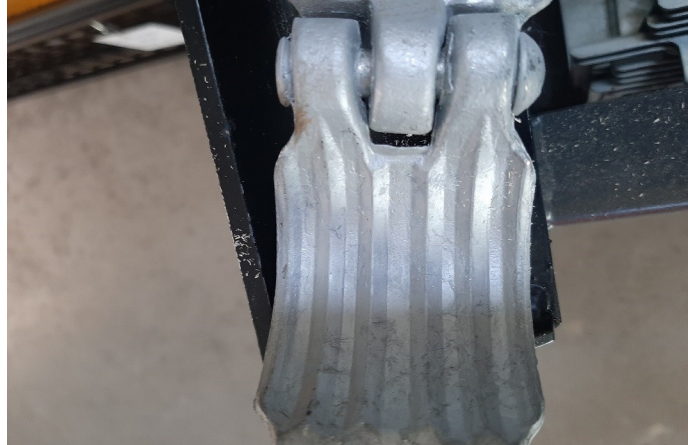
<p><b>Internal fluting defect</b></p> <p>If there is no fluting, this type of damage does not apply and the coupling can remain in the rental park</p>

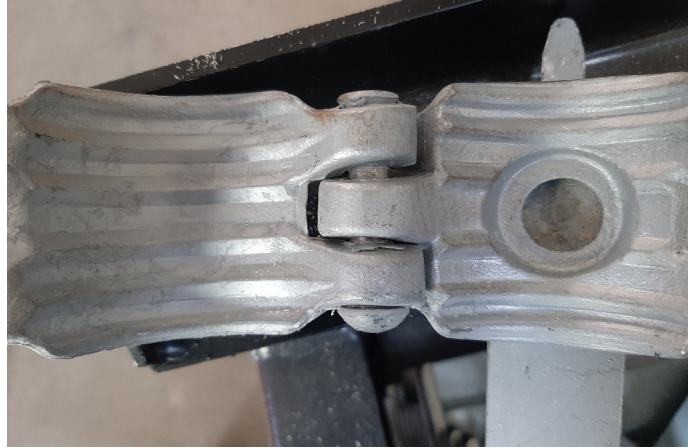
<p><b>Hinge Rivet damaged</b></p>

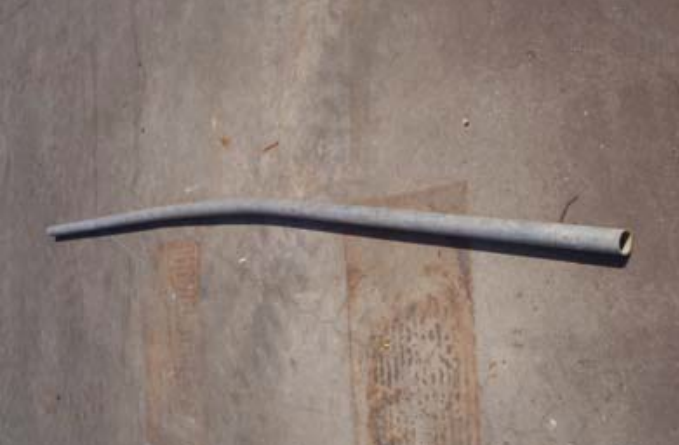
<b>Bent</b> <ul style="list-style-type: none"> <li>■ &lt; L/200</li> </ul>

<ul style="list-style-type: none"> <li>■ Or &gt; L/200</li> </ul>

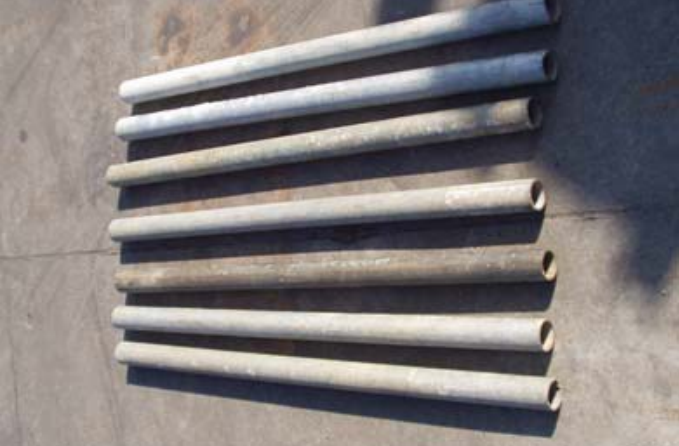
<b>Shortened on jobsite</b>

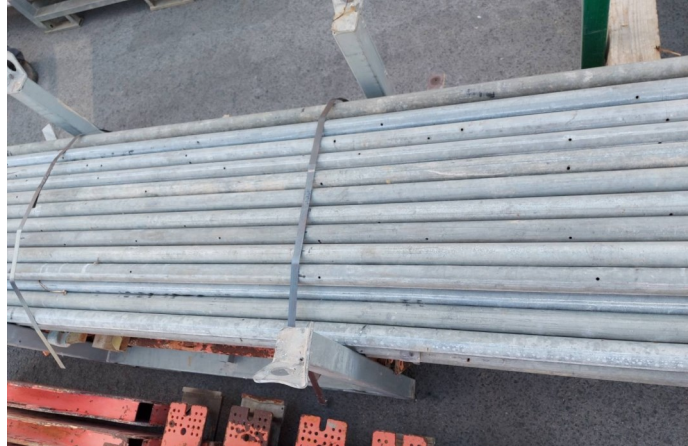
<p><b>Holes in tubes</b></p> <ul style="list-style-type: none"> <li>■ If possible</li> <li>■ Or if not possible</li> </ul>	<p>If possible:
