PERI Rental Criteria

LGS Weather Protection Roof

Content	Page
LGS Elements	2
Alu Rail URT Ledger	8
Supprt Roller UEW	15
Keder Rail Ridge Rail Eave Rail	16
Keder Connector URK URV	18
Tarpauling Reel URG	20
Reel Connector URG	21
Collar URP	22
Glossary	23

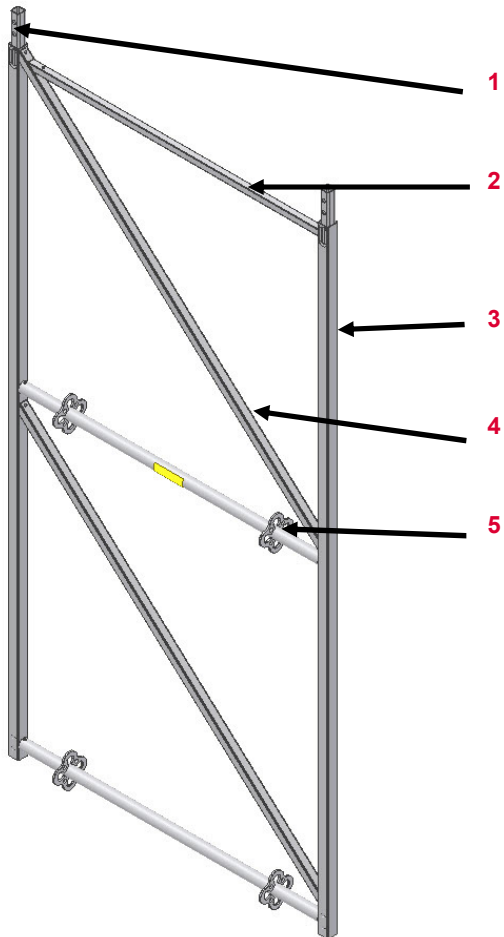
LGS Elements	Nr.	Description	Item number
--------------	-----	-------------	-------------

1	Connection
2	Vertical Pipe
3	Outer Pipe
4	Diagonal Pipe
5	Rosett

Gültig für	
LGS– Basic Element URB 300/150	104768
LGS– Eave Element URB 300/150	126483
LGS– Additional Element URB 150/150	104792
LGS– Middle Element URB 150/150	116122
LGS– Ridge Element URR 150	104769
LGS– End Element URB 150	105334

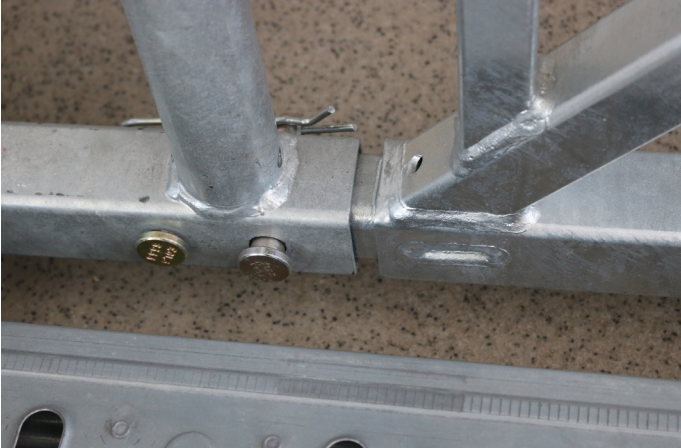
33.50.01 Junctions bent			
	<ul style="list-style-type: none"> ■ If possible (Connection possible) and no cracks in zinc layer 			
	<ul style="list-style-type: none"> ■ Or no longer possible 			
	<ul style="list-style-type: none"> ■ Or cracks in zinc layer

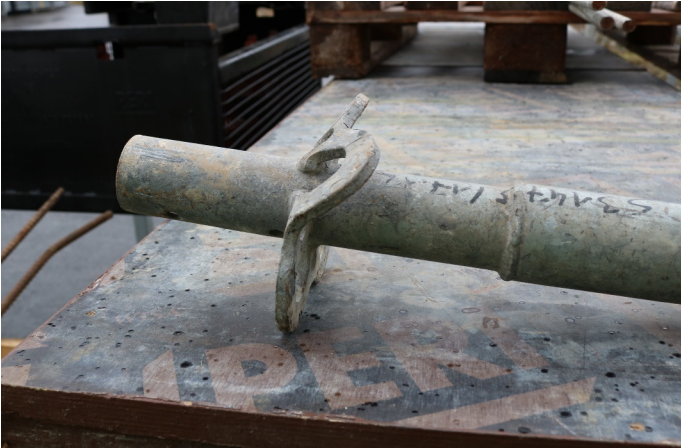
33.50.02 Rosetts bent			
	<ul style="list-style-type: none"> ■ ≤ 20 mm 			
	<ul style="list-style-type: none"> ■ Or > 20 mm 			
	<ul style="list-style-type: none"> ■ Or cracks in rosette

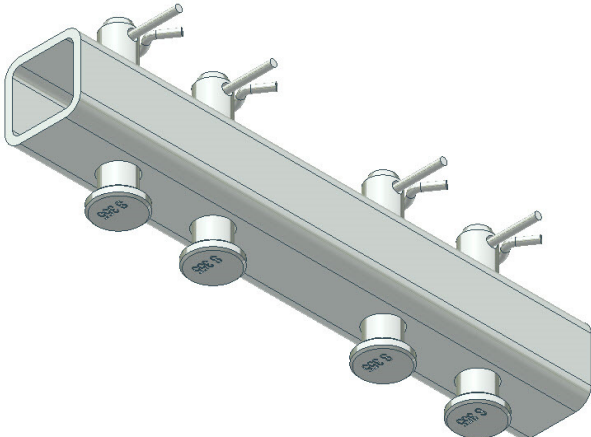
33.50.03 Bolt/ Cotter pin			
	<ul style="list-style-type: none"> Missing

<ul style="list-style-type: none"> Unusable due to violence

106031 (Bolt) 018060 (Cotter pin)

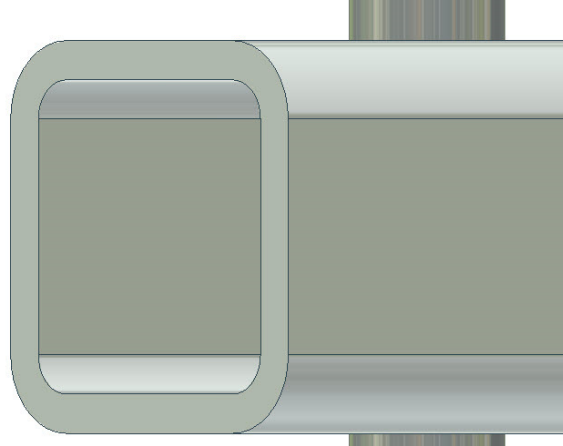
33.50.04 Pipe bent/dented			
	<ul style="list-style-type: none"> Connection still possible

<ul style="list-style-type: none"> Connection no longer possible

<ul style="list-style-type: none"> Cracks in zinc layer

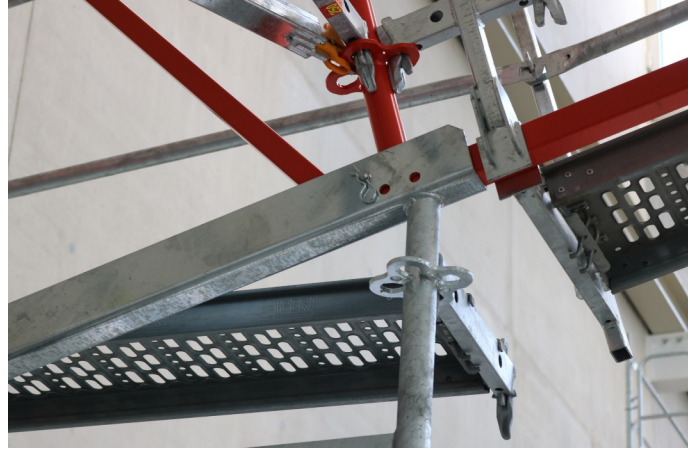
33.50.05 Rail bent	<ul style="list-style-type: none"> ■ If possible (Insertion of rail possible)

<ul style="list-style-type: none"> ■ Or no longer possible

<ul style="list-style-type: none"> ■ Or cracks in zinc layer

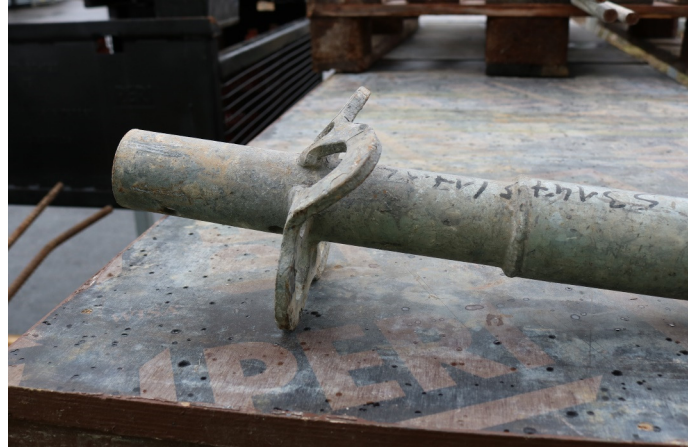
33.50.06 Rosetts bent	<ul style="list-style-type: none"> ■ ≤ 20 mm

<ul style="list-style-type: none"> ■ Or > 20 mm

<ul style="list-style-type: none"> ■ Or cracks in roset

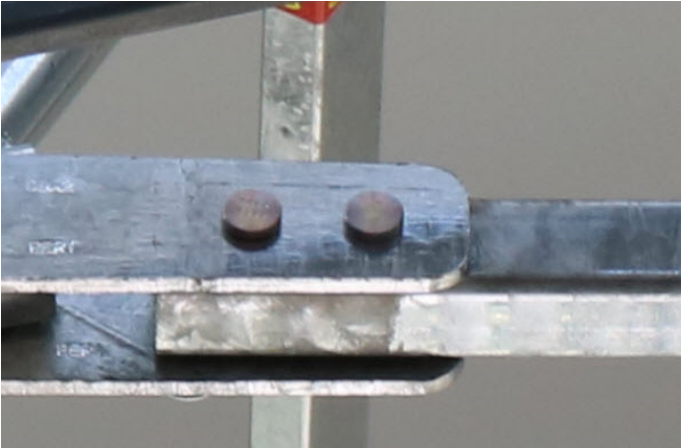
33.50.07 Bolt | Cotter pin | Screws | Nuts

- Missing

- Or unusable due to violence

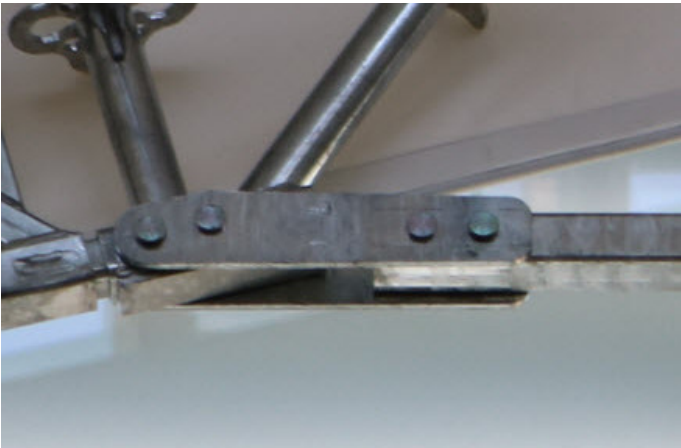
33.50.08 Brackets bent

- If possible

- Or if no longer possible

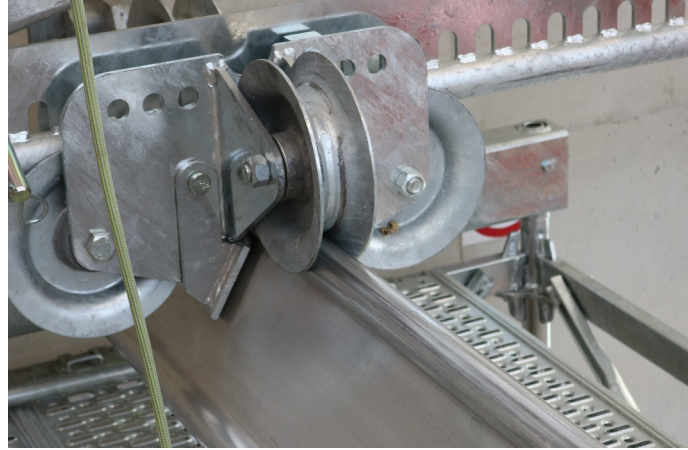
<p>33.50.09 Roll bent</p> <ul style="list-style-type: none"> ■ Function not limited and function lifting protection not limited ■ Or function limited 	<ul style="list-style-type: none">

104776 (roll) 	<ul style="list-style-type: none">

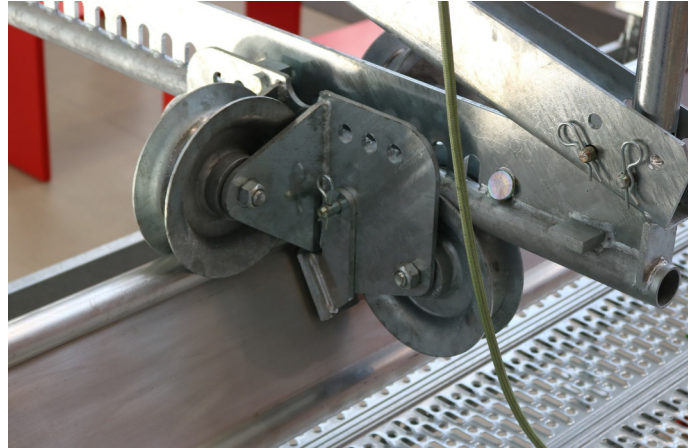
<p>33.50.10 Bolt Cotter pin</p> <ul style="list-style-type: none"> ■ Missing ■ Or unusable due to violence 	<ul style="list-style-type: none">

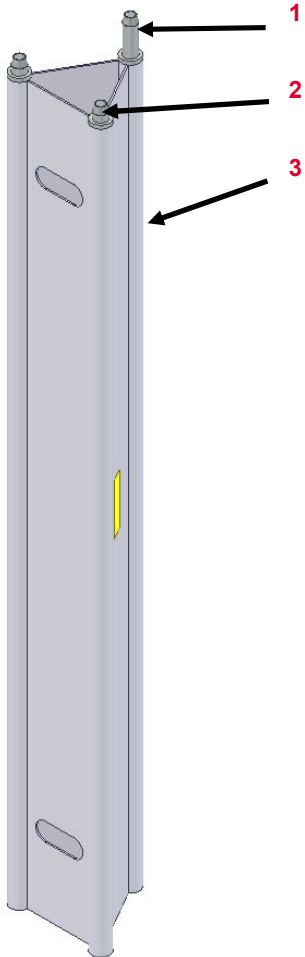
Alu Rail URT	Nr.	Description	Item number
--------------	-----	-------------	-------------

1	Connector long	104800
2	Connector short	104848
3	Guide rail

Valid for	
Alu- Rail URT 150	104790
Alu- Rail URT 200	104791
Alu- Rail URT 250	104796
Alu- Rail URT 300	104797

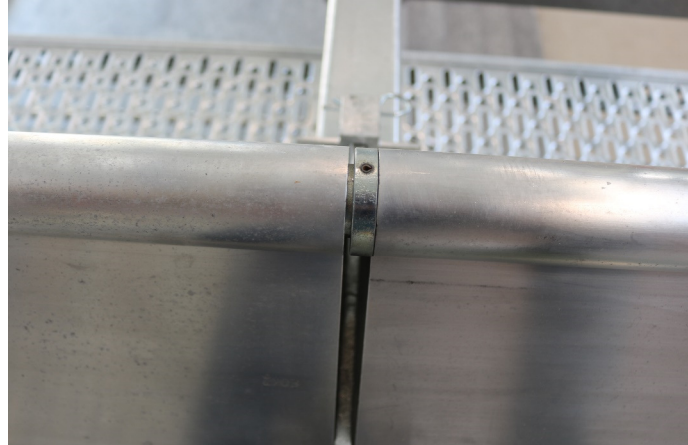
33.50.11 Connector			
	<ul style="list-style-type: none"> ■ Missing

<ul style="list-style-type: none"> ■ Or damaged due to violence

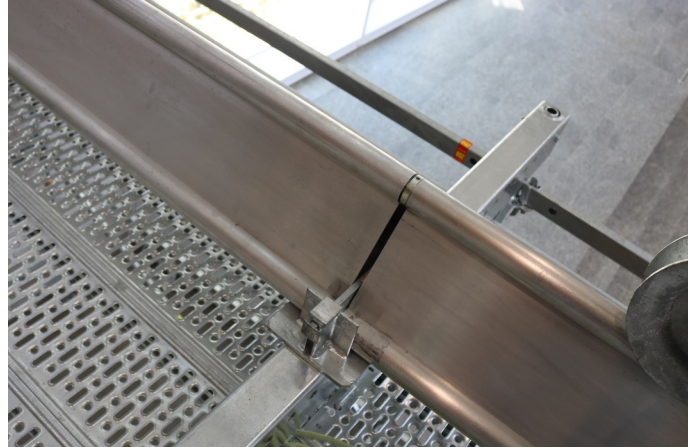
33.50.12 Guide rail bent			
	<ul style="list-style-type: none"> ■ Roll movable

<ul style="list-style-type: none"> ■ Or roll no longer movable

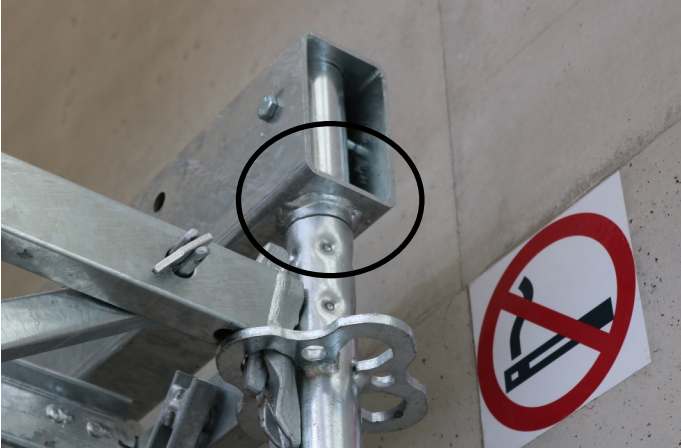
33.50.13 Junctions bent/dented

- Insertion of vertical pipes still possible
- Or no longer possible

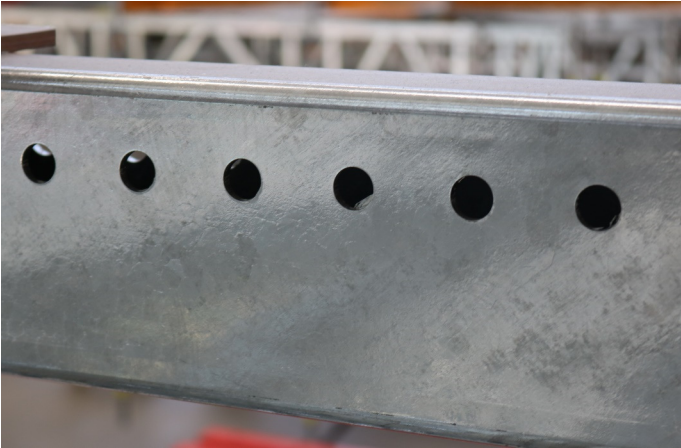
33.50.14 Hole diameter enlarged

- $\varnothing > 18 \text{ mm}$

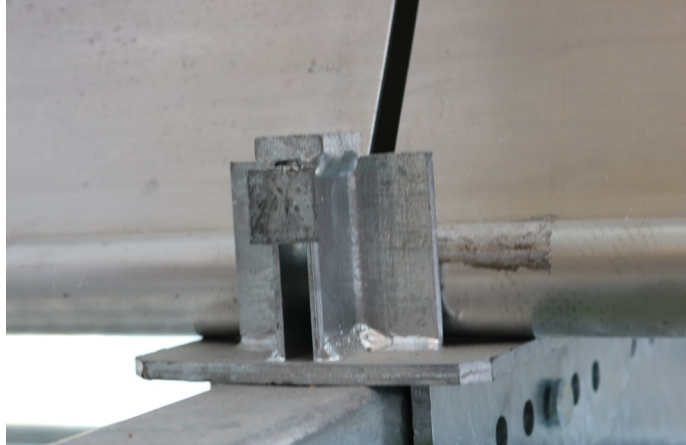
<p>33.50.15 Junction bent</p> <ul style="list-style-type: none"> ■ If possible (Rails can be inserted) ■ Or if no longer possible 	<ul style="list-style-type: none">

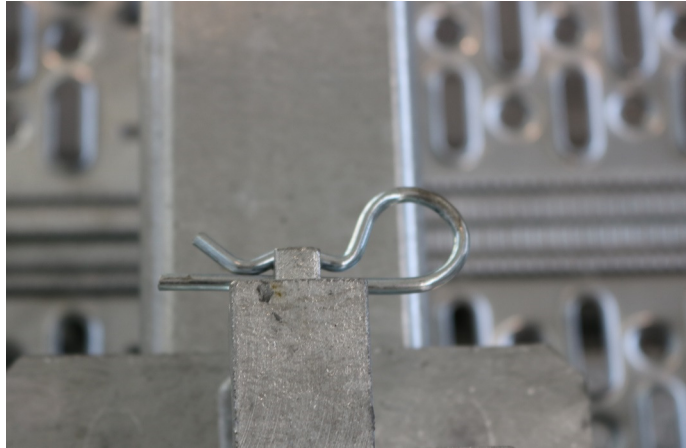
<p>33.50.16 Cotter pin missing</p>	<ul style="list-style-type: none">

022230 (Cotter pin) 	<ul style="list-style-type: none">

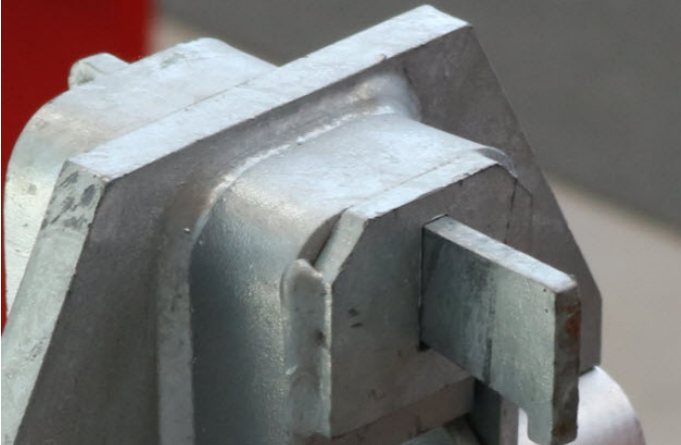
33.50.17 Bracket missing

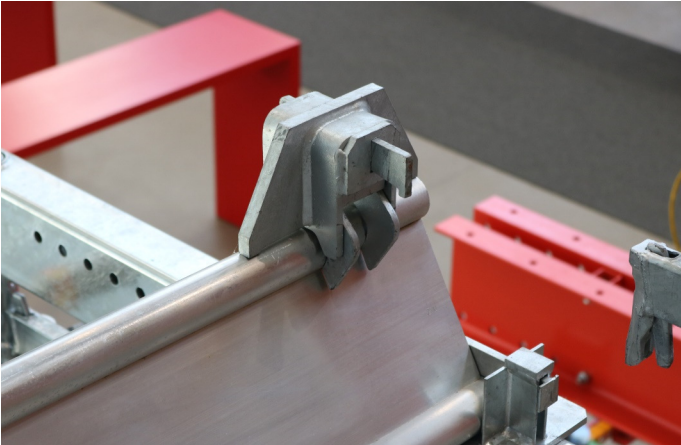
33.50.18 Parts bent

- If possible

- Or ff no longer possible

Afterwards check the functionality

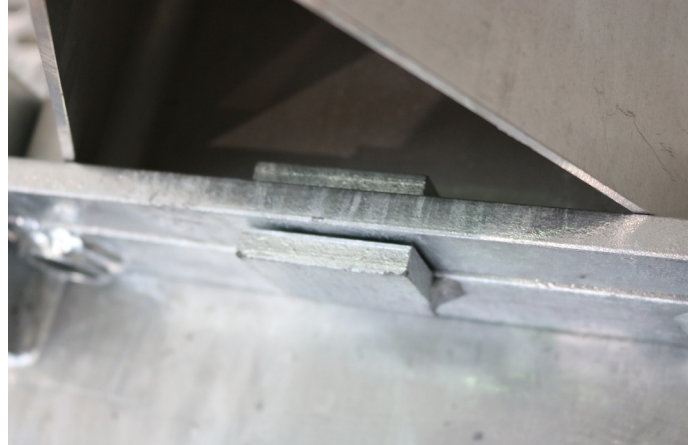
33.50.19 Plate bent			
	<ul style="list-style-type: none"> ■ If possible

<ul style="list-style-type: none"> ■ Or if no longer possible

<ul style="list-style-type: none"> ■ Or cracks in welding

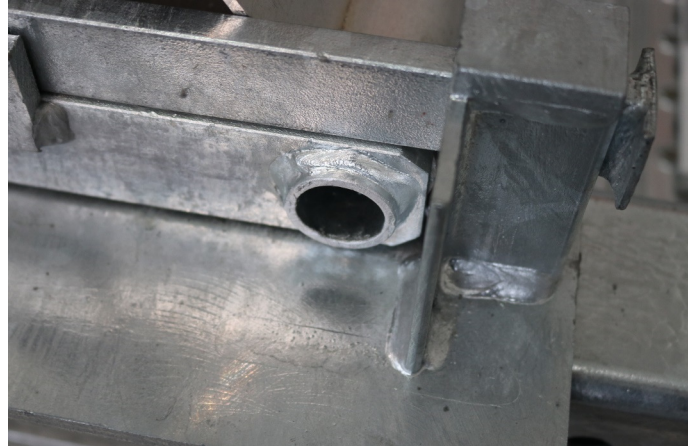
33.50.20 Tubes bent dented			
	<ul style="list-style-type: none"> ■ If possible (Insertion of tubes possible)

<ul style="list-style-type: none"> ■ Or if no longer possible

<ul style="list-style-type: none"> ■ Or cracks in zinc layer

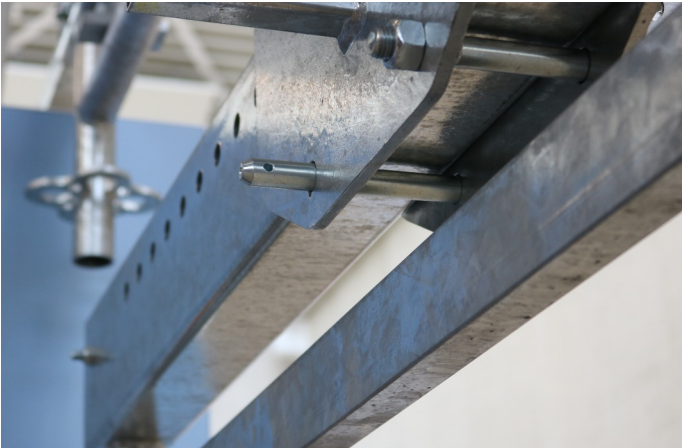
33.50.21 Bolt/Cotter pin

- Missing

- Or no longer usable due to violence

106191 (Bolt 24)
 106194 (Bolt 16)
 022230 (Cotter pin 5/1)
 018060 (Cotter pin 4/1)

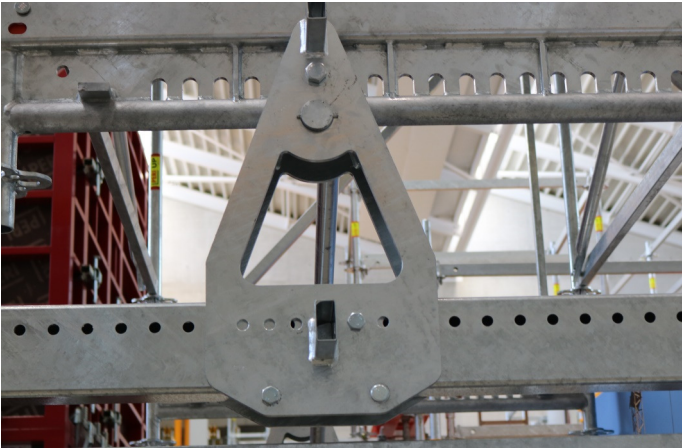
33.50.22 Bent/Dented

- If possible

- Or if no longer possible

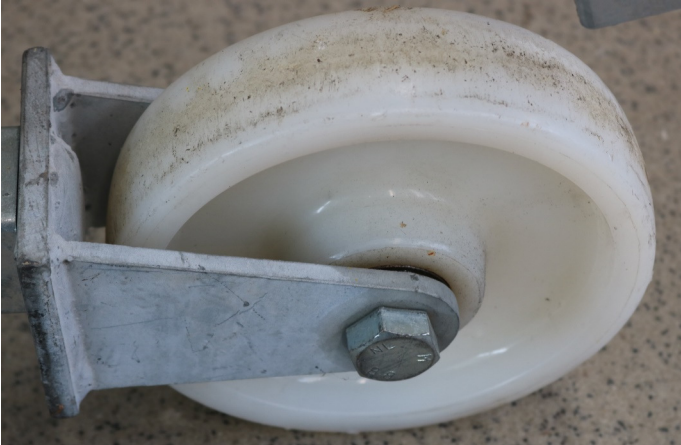
33.50.23 Roller guide dented <ul style="list-style-type: none"> ■ If possible (Roller movable) ■ Or if no longer possible

33.50.24 Roller <ul style="list-style-type: none"> ■ Worn ■ Damaged due to violence (functionality disturbed)

057164

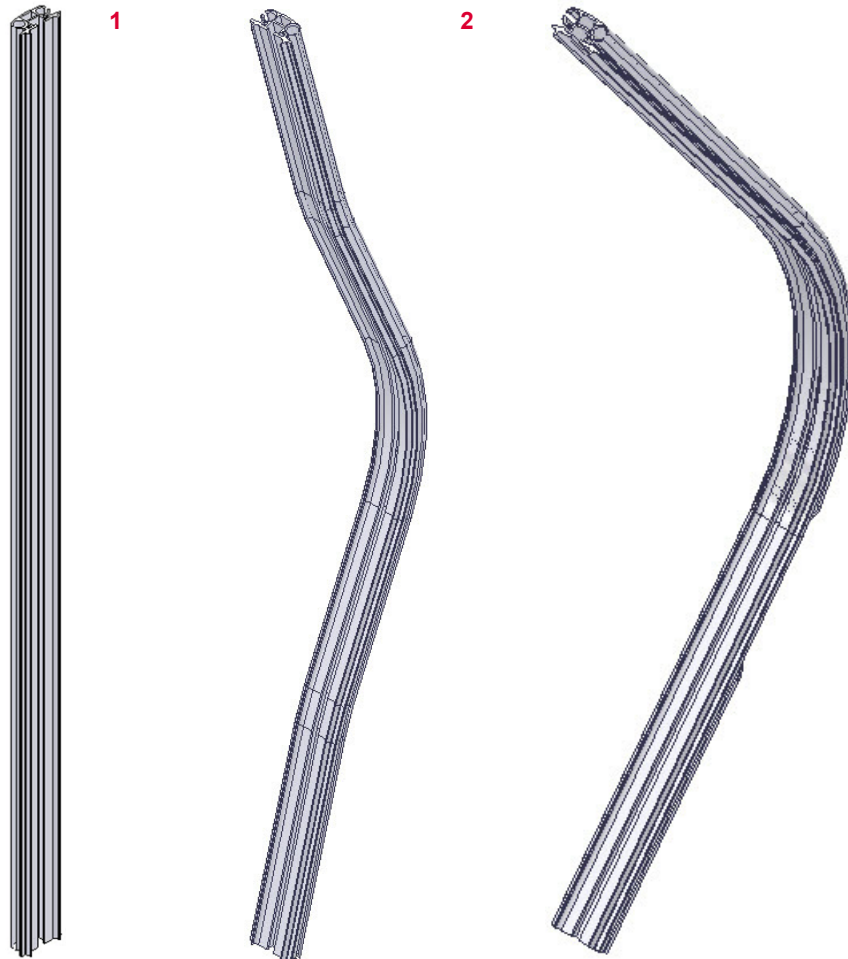
LGS Kederrail Ridge Rail Eave Rail	Nr.	Description	Item number
--	-----	-------------	-------------

1	Kederrail	
2	Ridge Rail	
3	Eave Rail

Valid for	
LGS Kederrail URK 150	127501
LGS Kederrail URK 300	127500
LGS Kederrail URK 600	126071
LGS Ridge Rail URK 150	126051
LGS Eave Rail URK	126491

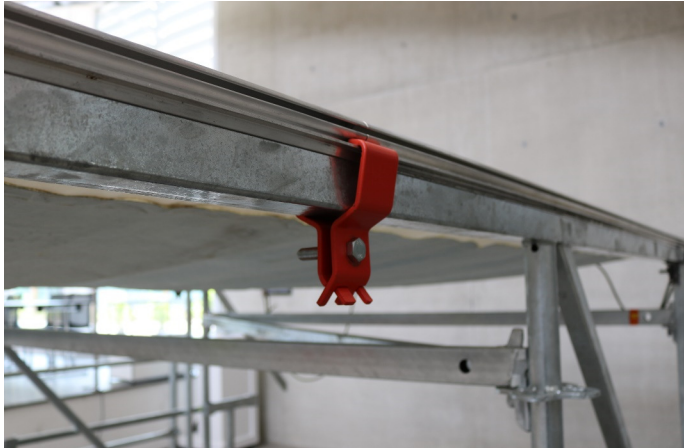
33.50.25 Rail completely bent

- Inserting of Keder sheeting possible
- Or inserting of Keder sheeting no longer possible

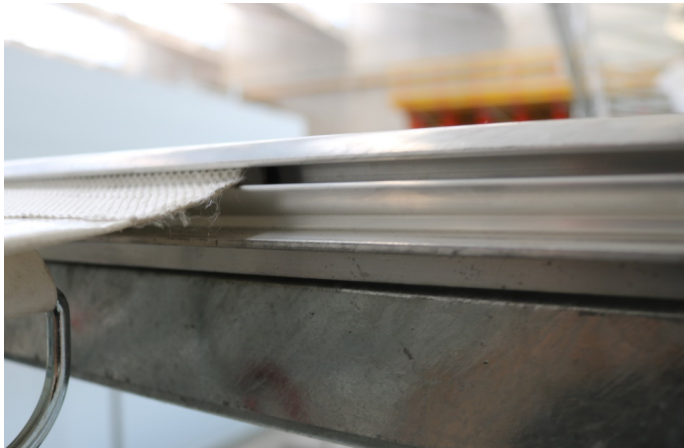
33.50.26 Guide profile bent | dent

- Inserting of Keder sheeting possible
- Or inserting of Keder sheeting no longer possible

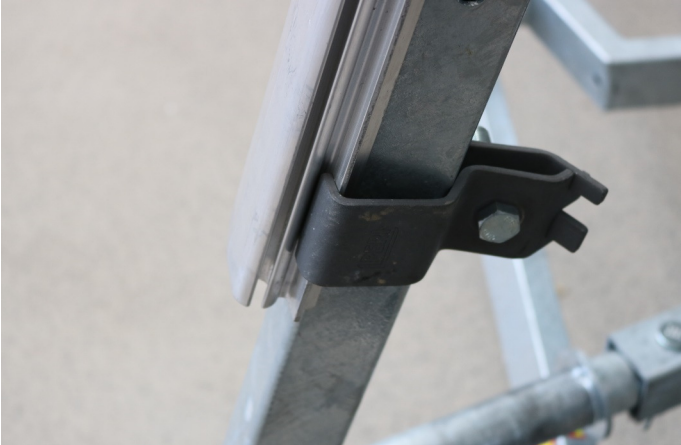
33.50.27 Claw bent

- If clamping of rail possible
- Or if no longer possible

125165 (Claw with nut)
125162 (Claw without nut)

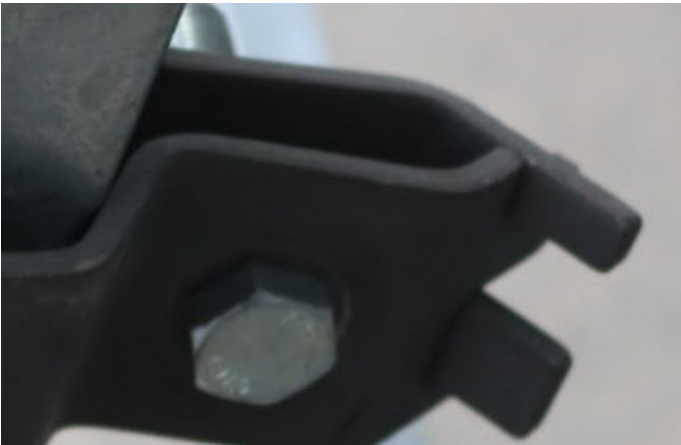
33.50.28 Screw

- Missing
- Or damaged due to violence

126001 (Bolt)
126001 (Bolt)

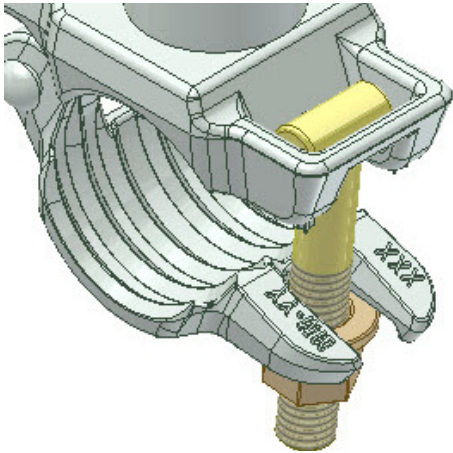
33.50.29 Hammer head bolt | Nut

- Missing
- Or damaged due to violence

131316 (Hammer head bolt)
710330 (Nut)

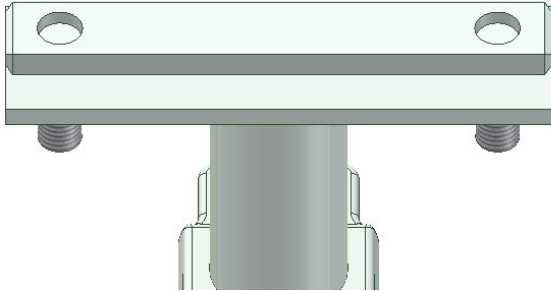
33.50.30 Rail bent

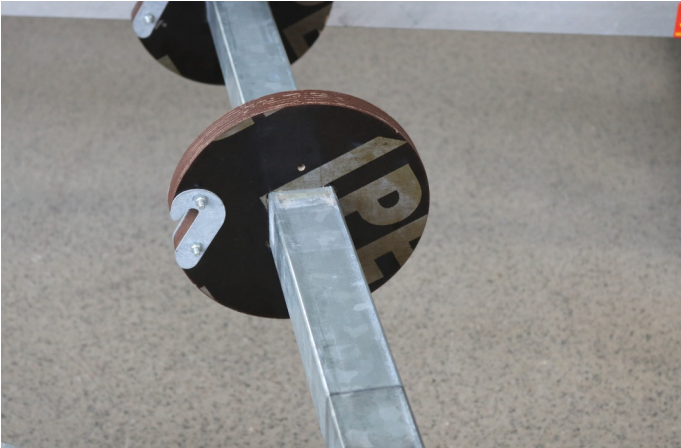
33.50.31 Disc not usable

126949

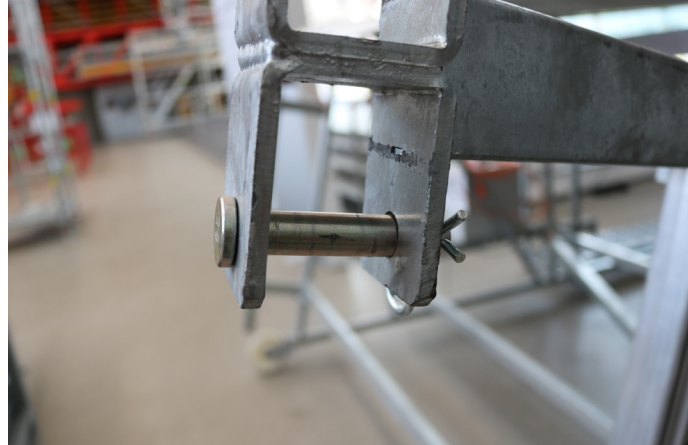
<p>33.50.32 Bolt Cotter pin Screw Nut missing</p>

<p>106031 (Bolt) 018060 (Cotter pin) 126924 (Screw) 710330 (Nut)</p>

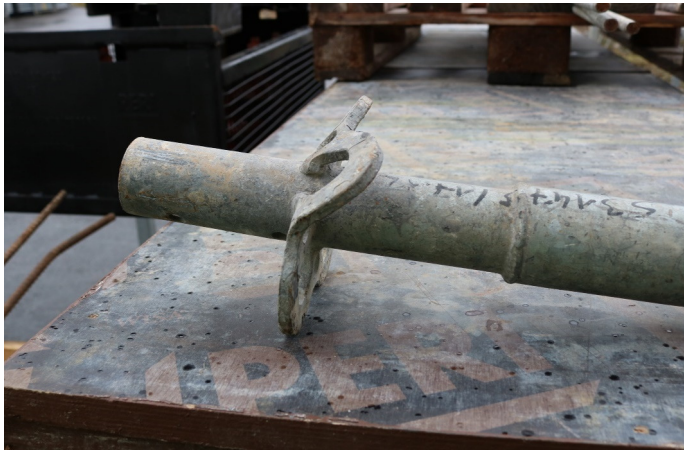
33.50.34 Rosetts bent

■ ≤ 20 mm

■ Or > 20 mm

■ Cracks in rosetts

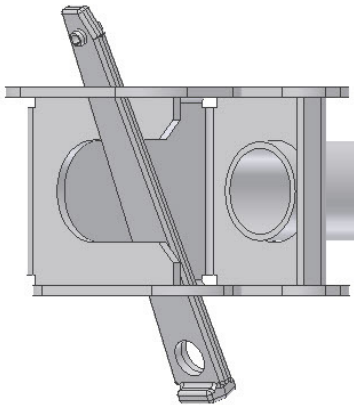
33.50.35 Wedge

■ Missing

■ No longer movable

024250 (Wedge)
105365 (Dowel pin)
